QUICK REPORT ON  
DAMAGE INVESTIGATION OF BUILDINGS AND HOUSES  
DUE TO MAY 27, 2006, CENTRAL JAVA EARTHQUAKE,  
INDONESIA

Masaoki TESHIGAWARA (Nagoya University)  
and  
Yoshiaki NAKANO (IIS, the University of Tokyo)

Building Survey Team  
Japan Society of Civil Engineers (JSCE)  
and  
Architectural Institute of Japan (AIJ)

June 16, 2006

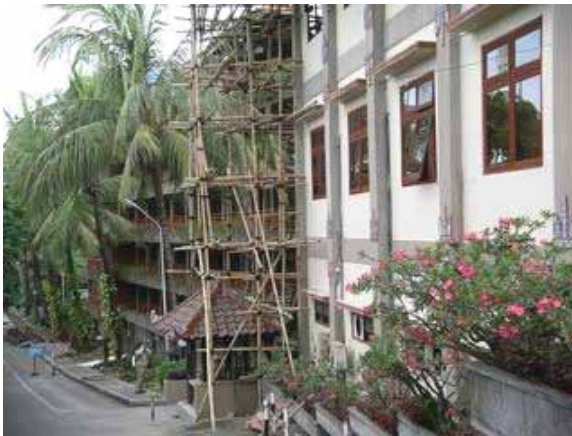
<== Lodging bldg.    Reception bldg. ==>

URM walls (brick walls) in RC frames had damage and a connecting bridge between two adjacent buildings (reception building and lodging building) was damaged at the expansion joint as well as its roof and handrail wall due to pounding. Roofing tiles on a steel truss system fell down through the ceiling board of guest rooms on the top floor, and falling debris were likely to have been life-threatening to guests staying at the time of the earthquake.

Closely neighboring structures with narrow gaps at expansion joints in between sustained pounding damage. Expansion joints should be therefore designed and constructed properly considering deformations expected during shaking.

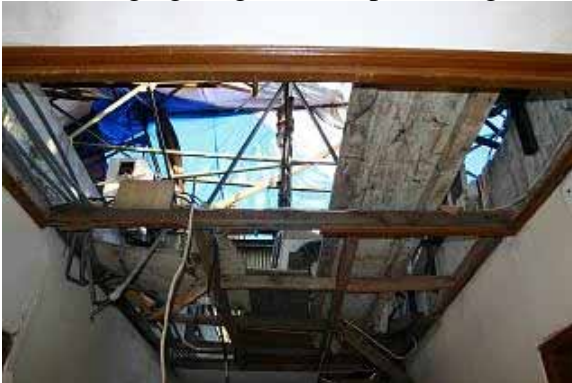
Damage to roof system above top story (some column rebar were not anchored to beams)

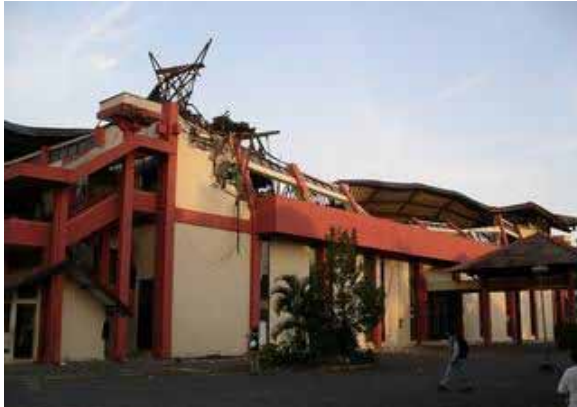
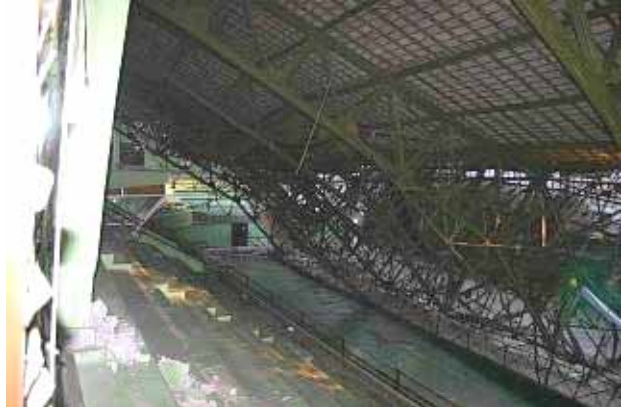
Extensive damage was found in cantilever RC columns on the top floor as well as in the roof system. The column damage may be attributed to the inertia force due to shaking, the inward force acting on the columns due to collapse of the roof, and the small amount of reinforcement provided in the columns.

Amongrogo Sport Center / Collapsed roof system associated with column failure underneath

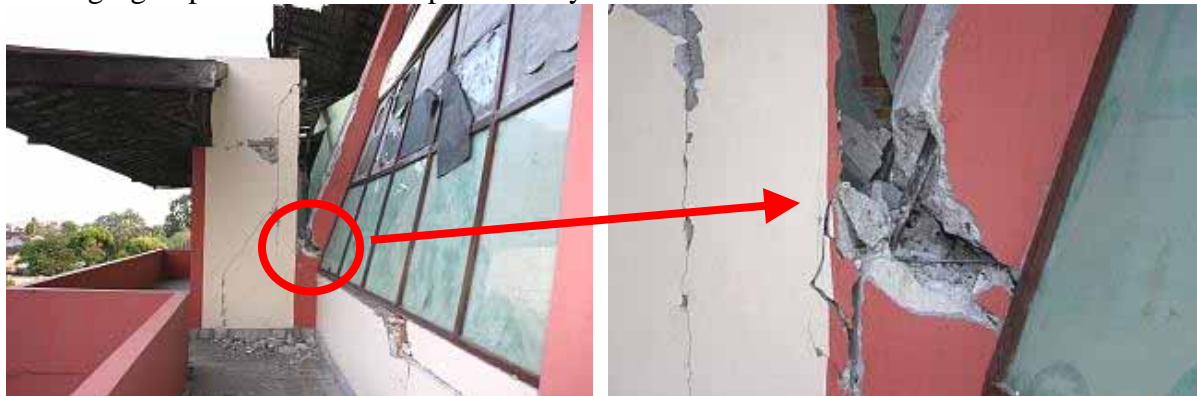
Heavy damage to RC columns and exposed rebar

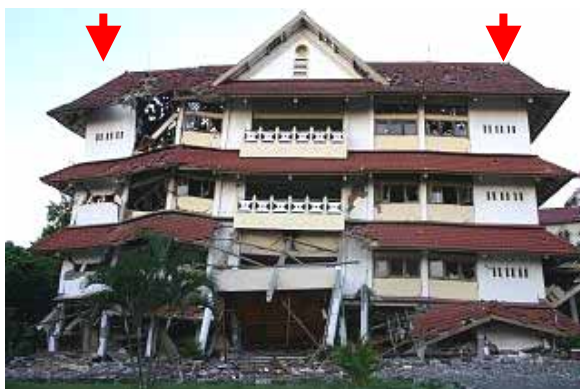
The university campus had several multi-story buildings. Serious structural and nonstructural damage was found in most buildings. One 4 story RC building, which was located just across the open square at the entrance gate, lost its first story due to beam-column joint failure. It had 2 URM wall frames while the neighboring 5 story building had 4 URM wall frames and did not collapse.

4 story building with 2 URM walls frames

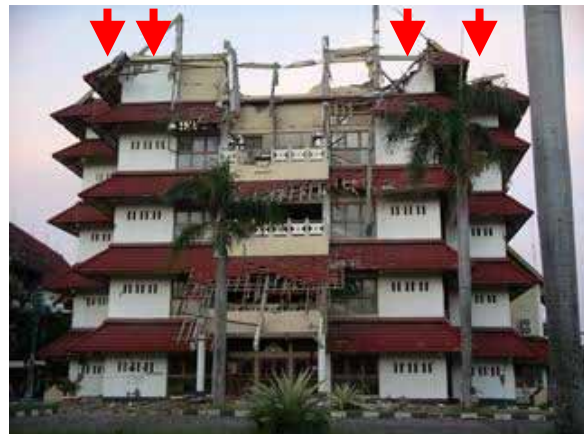
5 story building with 4 URM wall frames

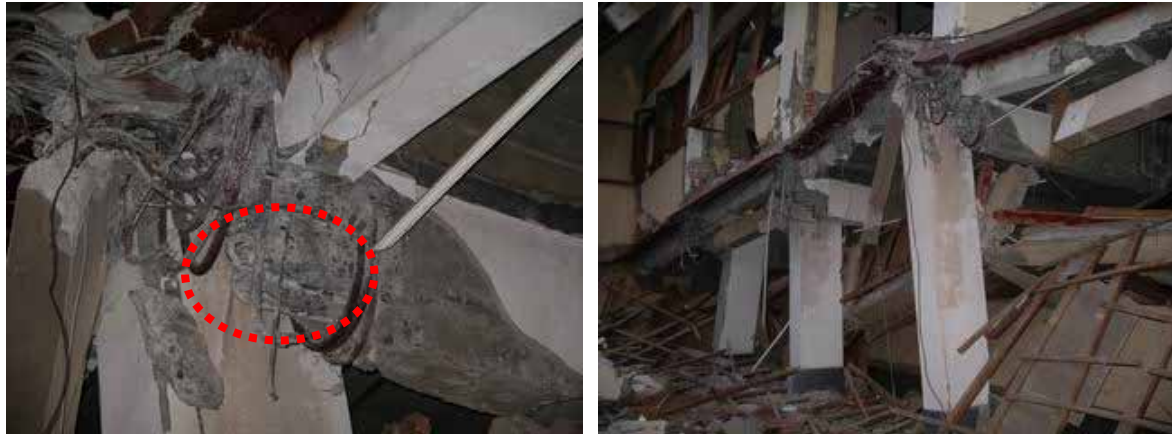
The damage was also attributed to the inadequate detailing of rebar ends placed at the bottom of beams and the insufficient section volume of beam-column joint as compared to the amount of reinforcing bars, which resulted in the pull-out failure of beam rebars at the joints.

University of Economic Science (STIE) / Beam bottom rebars inadequately anchored to joints

Concrete spalling at beam-column joints was observed in some RC buildings, exposing buckled longitudinal reinforcement. Some beam bottom reinforcing bars were improperly detailed and pulled out of the beam-column joints. They had 180-degree hooks in the ends but were straightly terminated in the joints without bent anchorage into the joint core concrete. Rigid beam-column joints properly confined with lateral reinforcement and beam reinforcement bent into the joint core to develop its full anchorage are most essential for RC structures to perform successfully during earthquakes.

Congestion of rebars was found in some buildings. Beams and columns therefore should be large enough to provide enough concrete volume at the beam-column joints for sufficient embedment length and anchorage of reinforcing bars.

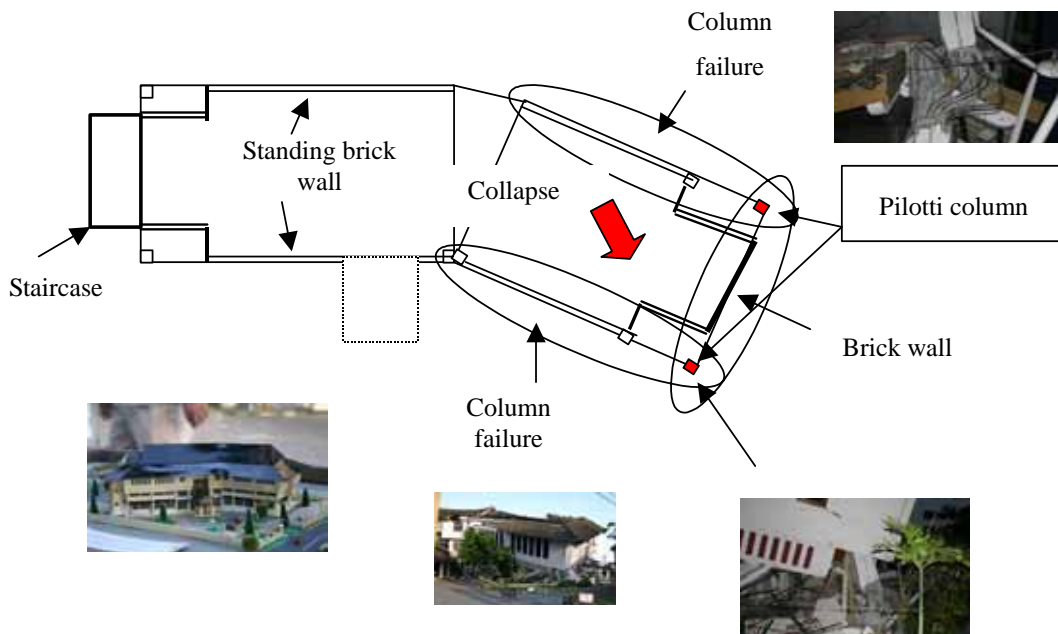
The 3 story RC office building lost its first story in the west wing due to beam-column joint failure in the 2nd floor while the east wing survived the shaking with damage to URM walls. Some rebars in columns were lap-spliced at joints, resulting in joint failure. The lateral reinforcement was placed at a space of 25cm to 30cm with 135-degree hooks. The serious damage to the west wing may be attributed to large deformations of soft columns supporting confined URM walls above on the west-end exterior frame and torsional response effects.

Building sketch and typical damage (BPKP)

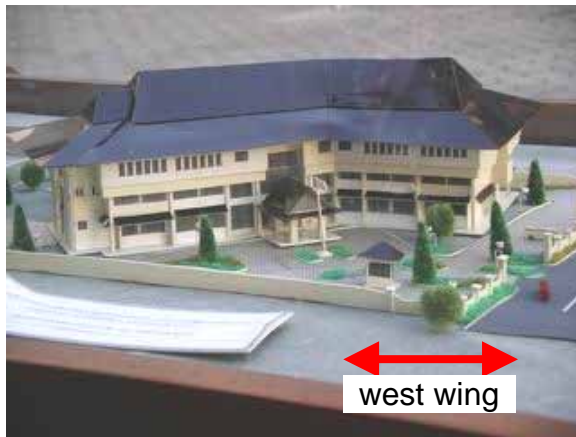
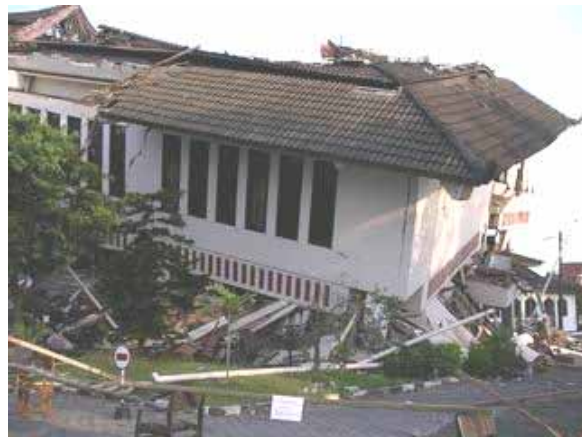
General view of Finance and Development Audit Agency (BPKP) and collapsed west wing

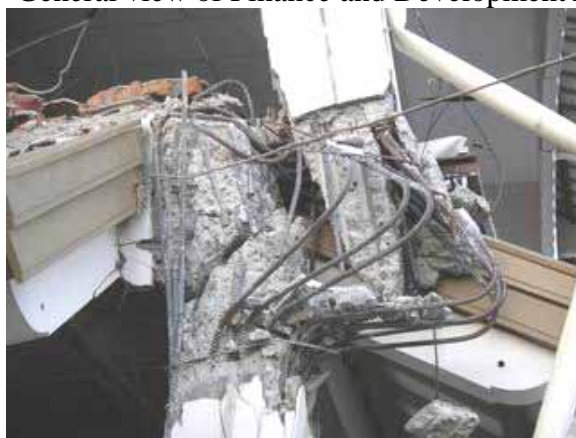
Beam-column joint failure

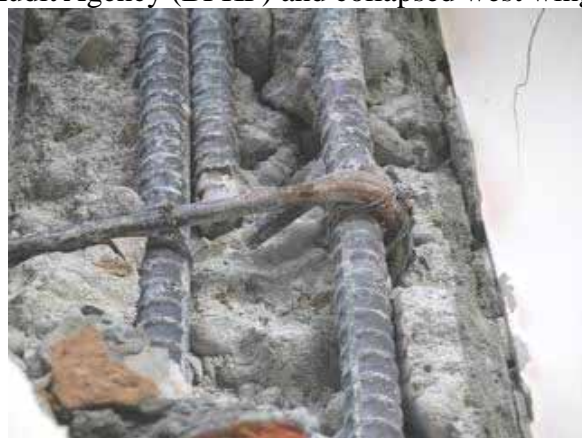
135-degree hooks in a column

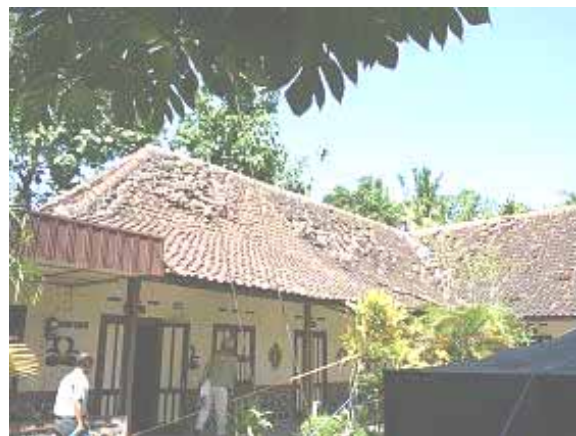
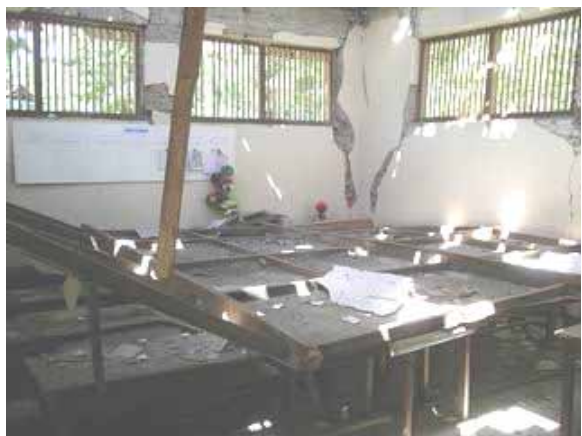
No lintel beams were found and the timber roof truss was directly placed on URM walls. Major damage was found in URM walls and the roof truss, and some ceiling boards fell down in the classrooms.

SD Tempel at Bambanglipuro / Heavy damage to URM wall and fallen ceiling boards

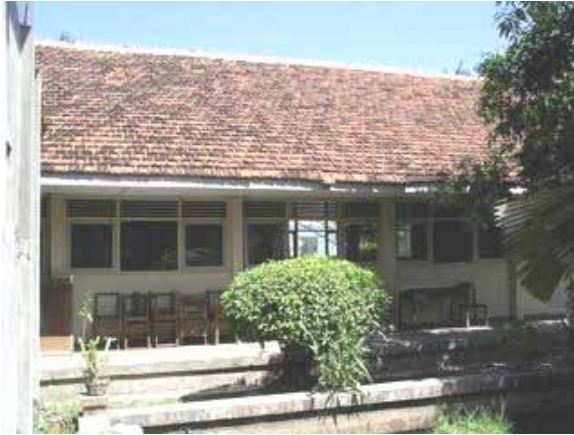
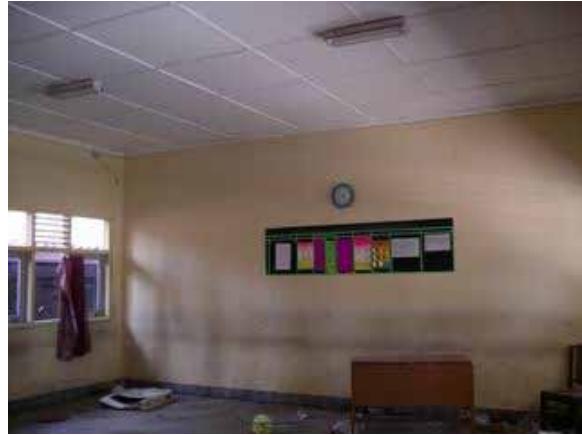
Each class had 3 bays in the longitudinal direction. No major damage was found in the structure.

SMP 2 at Bambanglipuro, Kecamatan Baglipuro / No major damage found in the building

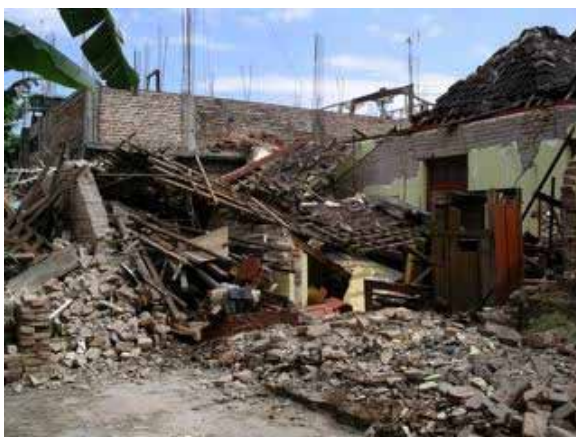
Houses in Imogiri were extensively devastated. They were URM structures with timber truss system and roofing tiles on it. URM walls were typically 20cm to 25cm thick with 2 or 1.5 brick units, having a geometry of 26cm x 12cm x 6cm. Since demolitions to reconstruct damaged houses had started in Imogiri, it was not easy to identify which debris were due to shaking and which were not. Those with RC frames to confine URM walls often survived the shaking although they had some damage.

Devastated URM house

Devastating damage was found in URM houses in Bantul Regency, Yogyakarta City, and Klaten Regency, killing residents due to heavy debris of brick walls. URM houses with RC beams and columns confining URM walls, however, were relatively less damaged, even when they were not intact. Providing RC frames to confine masonry walls, therefore, is strongly recommended to reduce structural damage to URM houses.

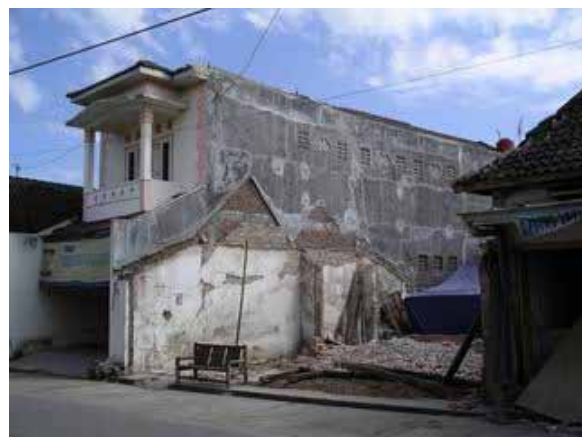
Survived house with URM and RC frame

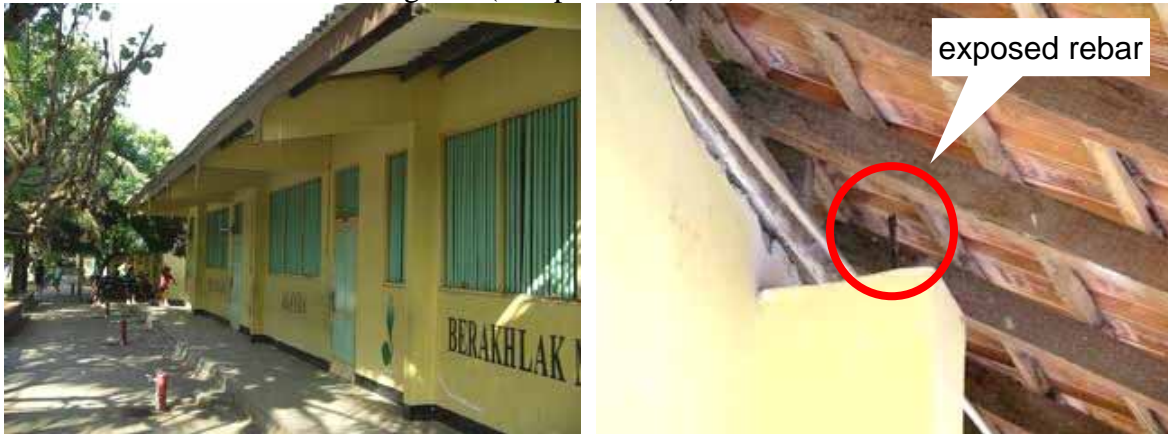
The school had 2 single story buildings. Each class had 2 bays in the longitudinal direction. Each bay was 3.5m long and the column in the center of each two-bayed frame was 175mm thick and 350mm wide. The eaves of one building were supported by  $\Gamma$ -shaped RC columns with cantilever beam while those of the other were supported by columns provided at the tip of eaves. No major damage was found in the structures. Note that less damage was found in the coastal areas around Parangtritis (to Opak river) than inland areas.

SD 2 Parangtritis / No major damage found in the building

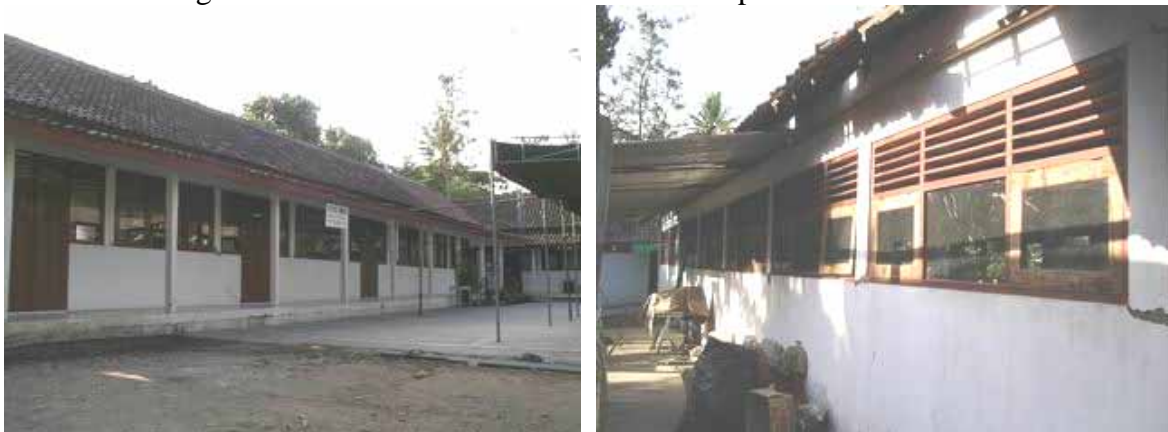
Each class had 2 bays in the longitudinal direction. Each bay was 3.5m long. Columns had flexural cracks at both ends. The presence of reinforcing bars was not confirmed at the site since the building had minor cracks and rebars were not exposed.

SLB-PGRI Trimulyo / Cracks found in column ends

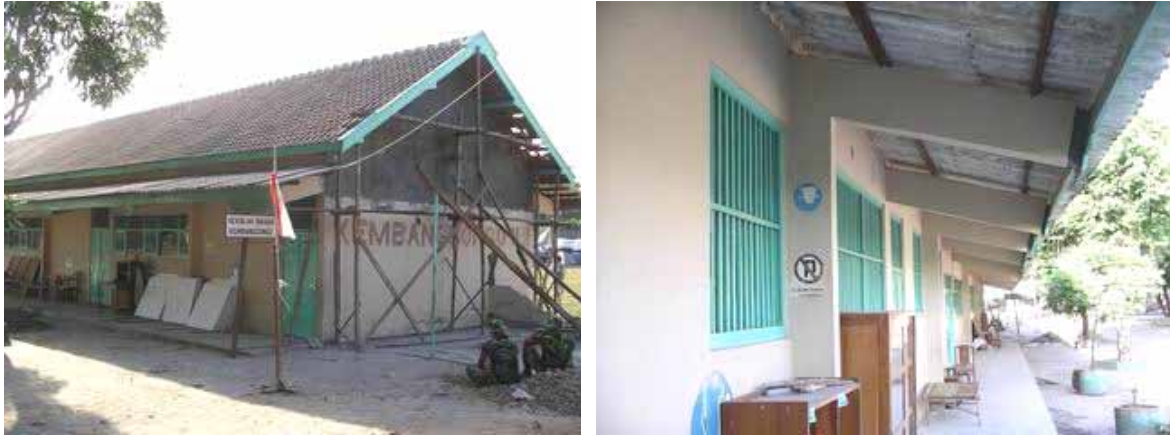
Γ-shaped RC columns with cantilever beam, which was similar to SD 2 Parangtritis. The exterior URM wall was damaged and repaired, but no other major structural damage was found in the structure.

SD 2 at Kembangsongo / No major structural damage found in the building

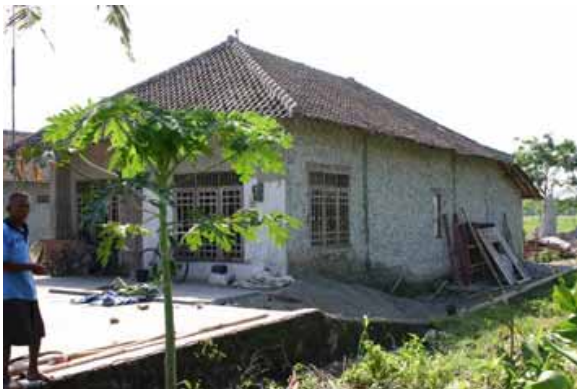
Traditional stone masonry houses in Gantiwarno Sub-Regency had some damage in masonry walls. They had some RC beams on the wall but no RC columns were provided in the houses. Although they were heavy, the stone masonry walls were thick and long enough to resist and survive the shaking. Another traditional house older than the stone masonry construction had minor damage since they had light bamboo-net walls. The bamboo-net house investigated by the reconnaissance team was older than 70 years.

Stone masonry house with cracks in walls

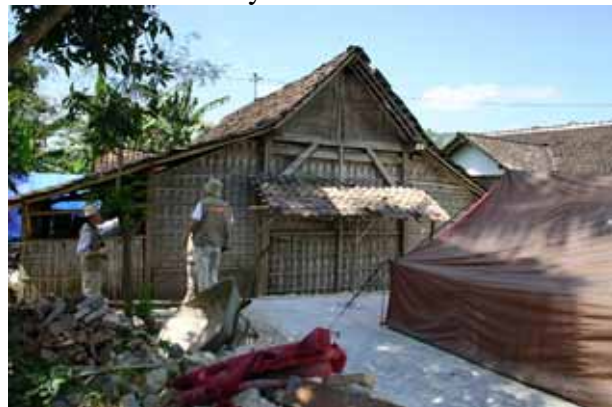
Bamboo-net wall house

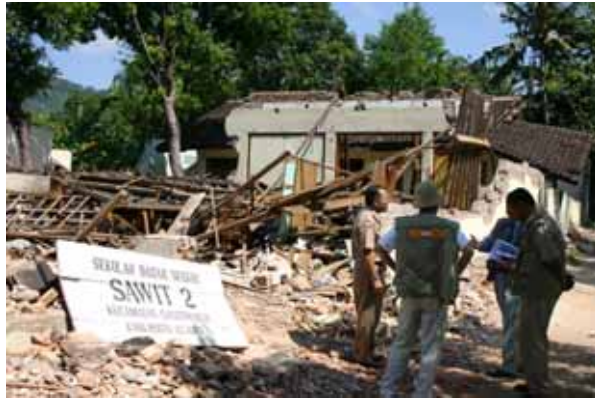
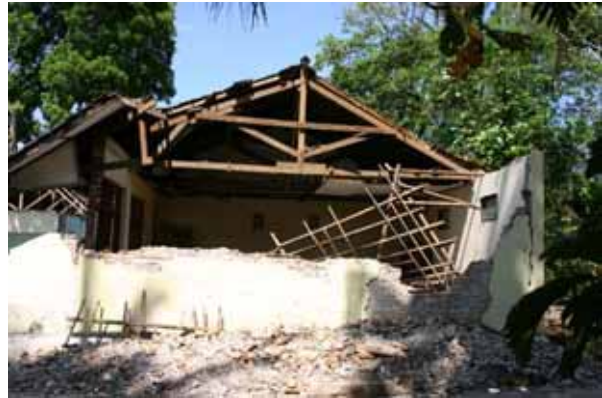
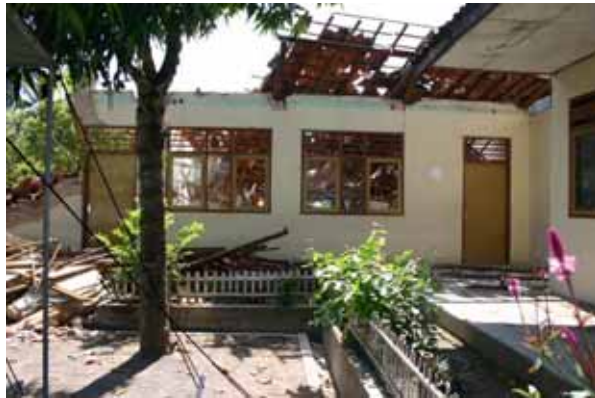
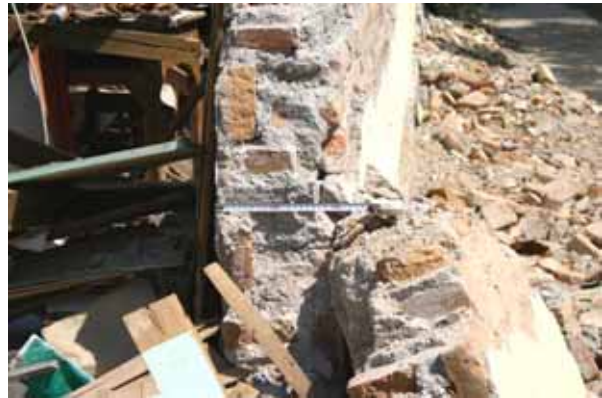
The school building most probably had RC columns only at the 4 exterior corners but no columns in the middle of the structure. Each class had 2 bays and each bay was 3.5m long. Extensive damage was found in 20cm thick URM walls and the roof system.

SD Sawit at Gantiwarno / Collapsed building

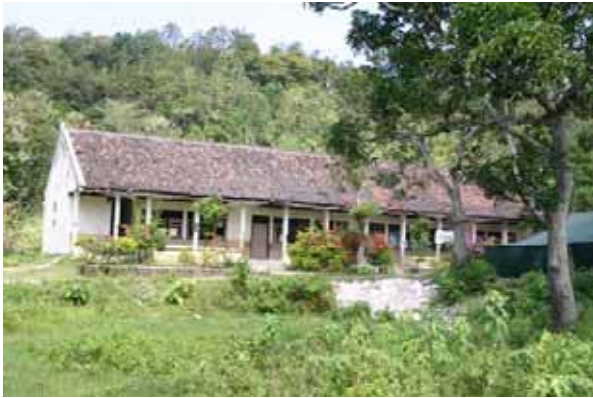
Building #1 : URM with RC columns

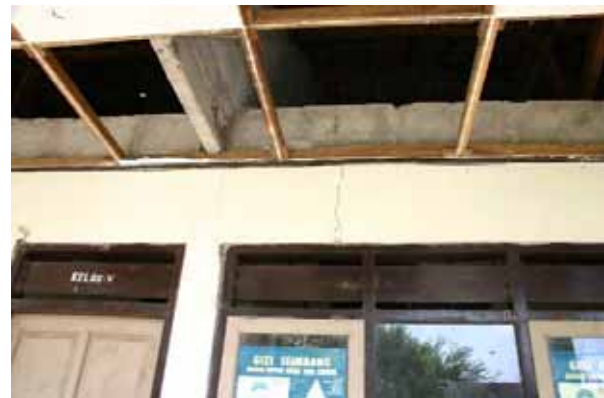
Building #1 : RC column and beam

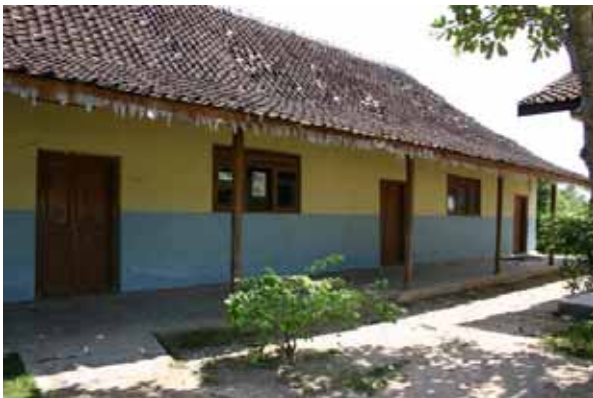
The school had 3 buildings, one of them (building #2) was stone masonry structure constructed in the 1970s while the other two buildings (#1 and #3) were URM structure with RC columns. Each classroom of the building #1 had 3 bays, each of which was 3m long. Damage to the roof system and ceiling boards was found in buildings #1 and #3 while cracks in URM stone walls were found in building #2.

Building #2: Stone masonry structure

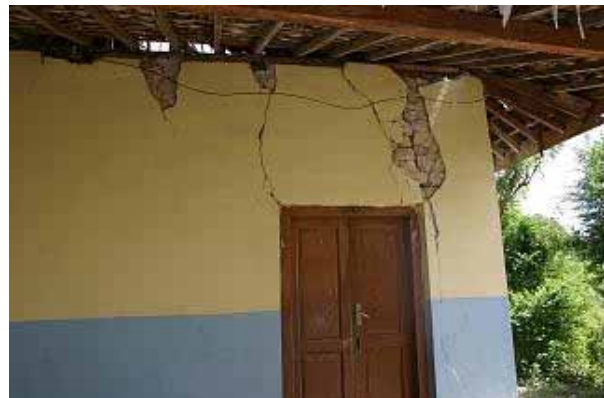
Damage to corner wall

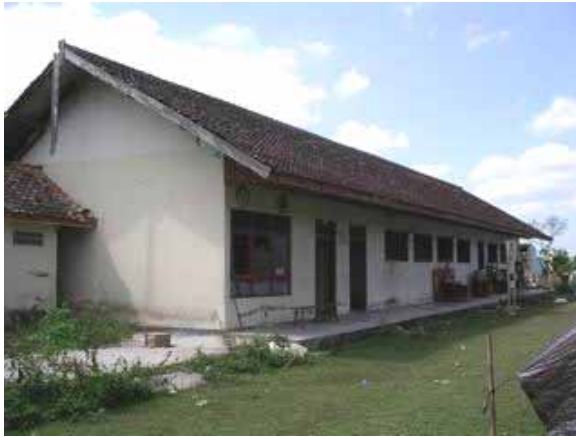
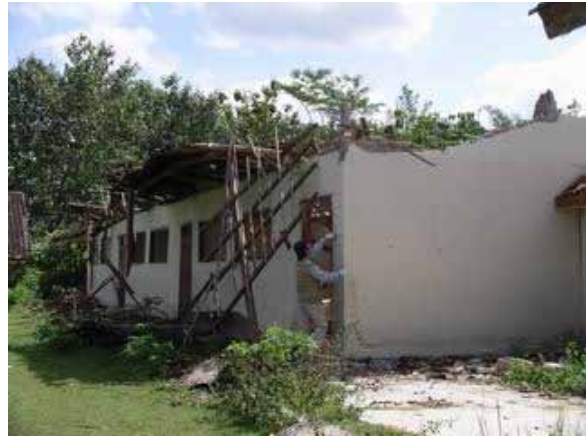
The school had two buildings, one was seriously damaged in the roof system and the other survived the shaking. Columns having a geometry of 150mm x 150mm with 4- $\phi$ 13 main rebars and  $\phi$ 6 hoops were provided between classrooms. Mid-span walls were 150mm thick and 500mm wide. The eaves were supported by the timber truss fastened to RC columns

One building extensively damaged in the roof system

Even when a building had minor structural damage, some schools were significantly damaged in their roof system. Since the earthquake occurred early in the morning (5:53 local time), the loss of human lives was minimized. Falling debris such as bricks, ceiling boards, roofing tiles etc. are significantly life-threatening especially to school children. The structure underneath the roof should be rigid and strong enough to properly support the roof system during an earthquake. As pointed out in (1) above, providing RC frames is strongly recommended to provide sufficient in-plane and out-of-plane stiffness and strength to buildings.

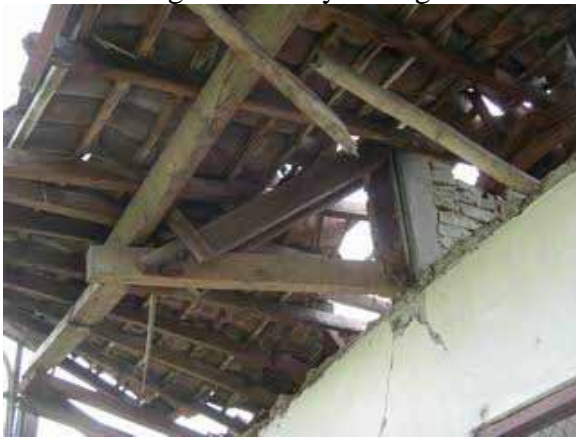
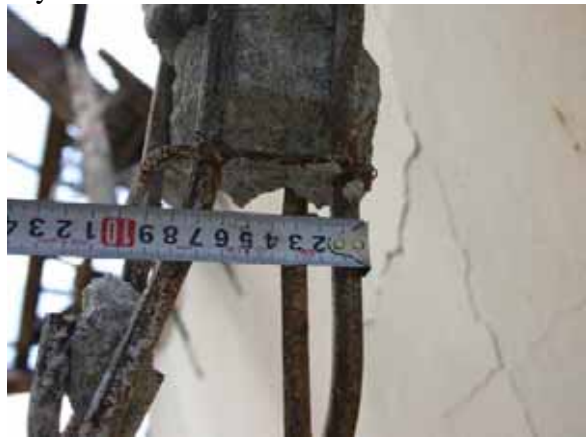
SD Pesu / Exposed rebars in a column supporting roof system above
