# **Quick report of the JSCE/AIJ/EWBJ Joint Survey for the Indonesia Bengkulu Earthquake of September 12, 2007 (Ver. 1.1, Feb. 1, 2008)**

Kazuo KONAGAI, Leader, Professor, Institute of Industrial Science, University of Tokyo, Japan,  
Masaomi TESHIGAWARA, Professor, Department of Civil Engineering, Nagoya University, Japan,  
Yoshiaki NAKANO, Professor, Institute of Industrial Science, University of Tokyo, Japan,  
Takashi KIYOTA, Research associate, Tokyo University of Science, Japan,  
Takaaki IKEDA, Researcher, Institute of Industrial Science, University of Tokyo, Japan,  
Yusuke FUKUNAGA, PhD Candidate, University of Tokyo, Japan, and  
Tomoji SUZUKI, Secretary General, JSCE Indonesia Section.

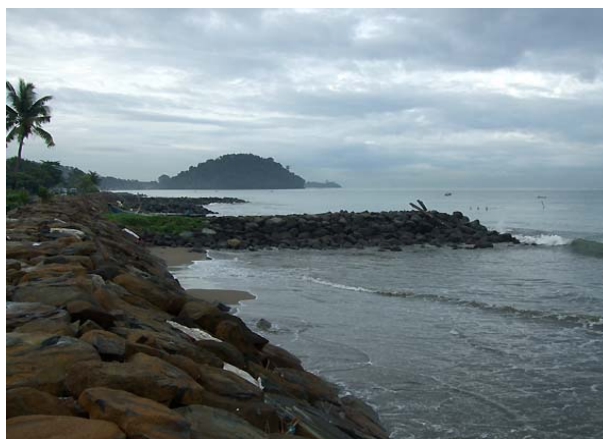
(a) Dike along the coast of Padang

Fig. 1. Coast of Padang (Location:  $00^{\circ}56'48.7''S$ ,  $100^{\circ}21'6.3''E$ ): A masonry dike system (tsunami wall) of about 3m high has been constructed along the coast of Padang. Some toe stones are being embedded in the sand. A spoonful of sand ( $D_{50} \cong 0.15$  mm) from the shore included some iron sand (placer sand) as shown in the photo (b). This may suggest that the shore line is being eroded inland with heavier substances remaining there. The December 26, 2004 Tsunami have strip sand off shorelines elsewhere, and the great erosion/sediment-reworking potential may be a cause of this erosion. Long term monitoring of the shoreline change is recommended.

Along gradually thinning sandy shorelines, masonry sea dikes and/or tsunami walls can sink into the sands. Some walls may not be high enough to stop tsunami waves and water may be stopped inland. The stopped water can flow back into the ocean through where the walls have been subsided seriously. At these points the flows will be fast enough for these points to be eroded further deep. Long-lasting erosion and accretion process of sand is to be monitored for laying out important facilities such as tsunami walls.

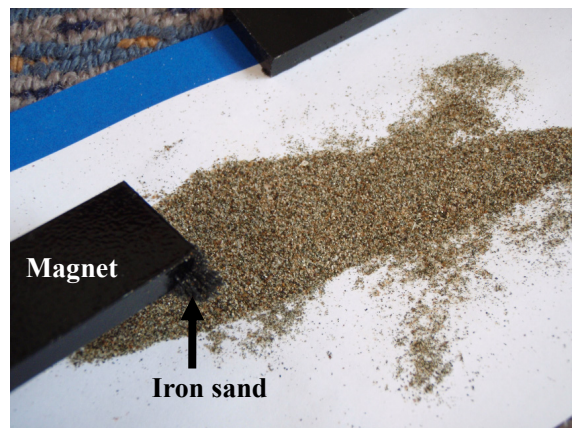
(b) Iron sand (see black arrow) included in a spoon-full sand

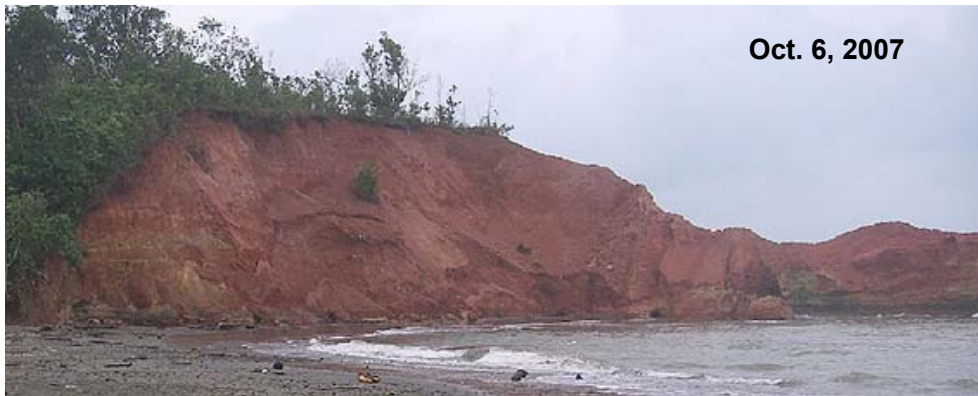
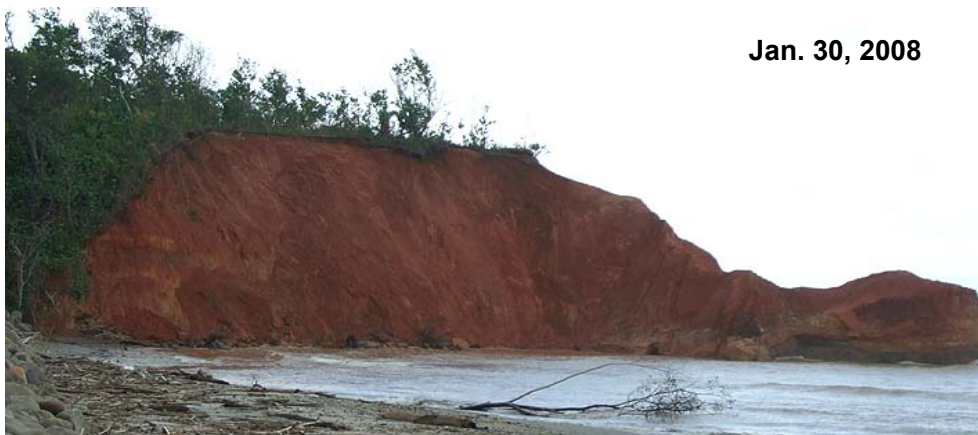
Fig. 2. Exposed slip surface of laterite (Location  $3^{\circ}25'38.5''\text{S}$ ,  $101^{\circ}53'51.4''\text{E}$ ): The photo above was taken on Oct. 6, 2007 by O. Aydan, while the photo below shows the same surface four months later (photo by K. Konagai). With its toe being washed by sea waves, the slope has been eroded slightly inland. See some trees on slopes have disappeared.

Fig. 2 and 3 compare same laterite slopes at different times. With the feature of laterite described above, their deformations will be slow. If their toe parts are being eroded steadily, sudden movements of landslide masses may occur.

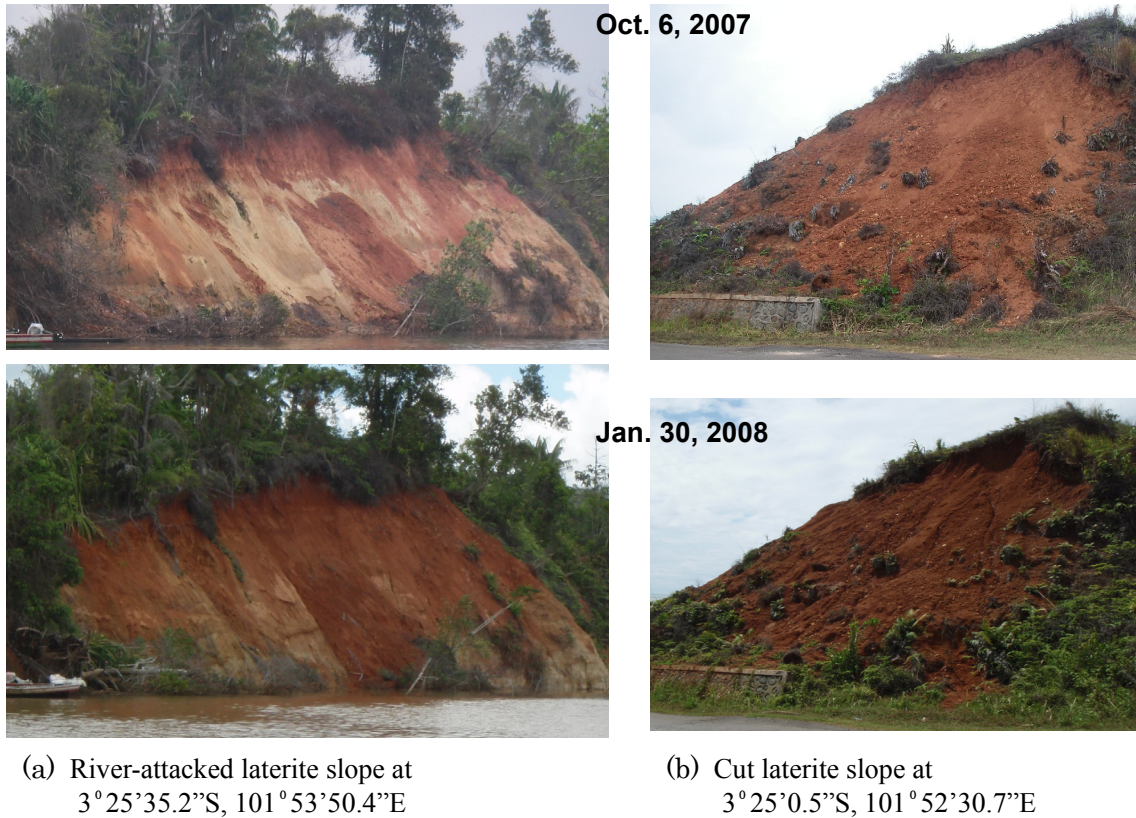
Fig. 3. Exposed slip surfaces of laterite: The photos above were taken on Oct. 6, 2007 by O. Aydan, while the photos below show the same surfaces half year later (photo by T. Kiyota). Excluding some minor scratches, no clear change was observed.

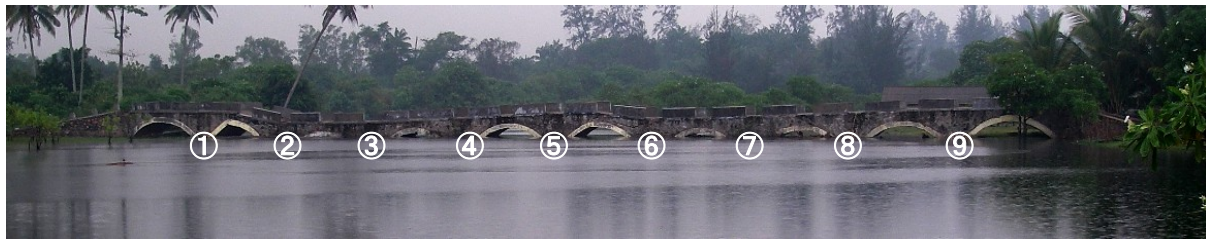
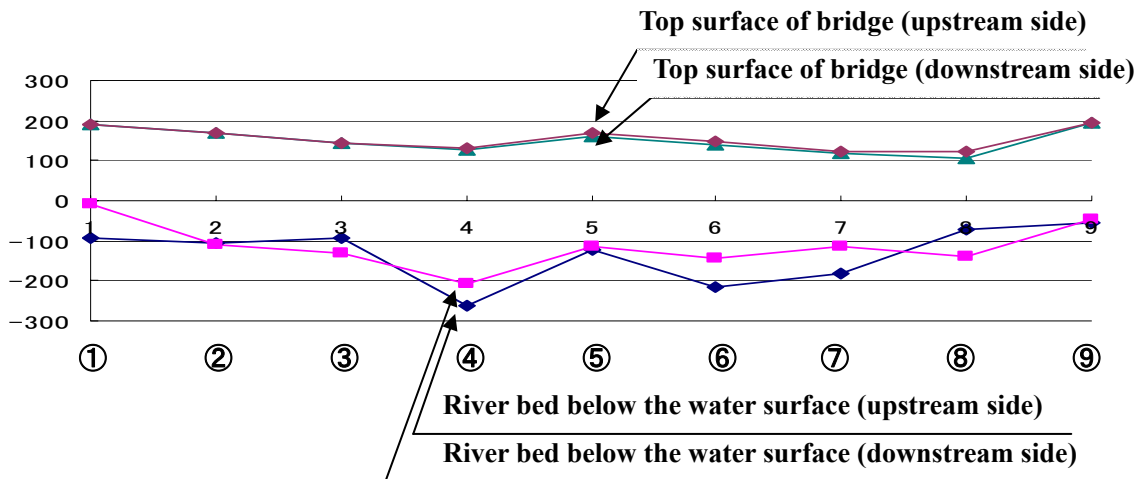
Fig. 4. Masonry arch bridge (Location  $2^{\circ}1'20.5''S$ ,  $100^{\circ}52'42.5''E$ ): Some foundations of this masonry arch bridge have sunken into the riverbed of fine sand. Elevations of the road surface above the water level were measured immediately above the nine piers. Though riverbed depths differ between upstream and downstream sides, cross-sections of the bridge did not show any clear sign of inclination. Riverbed erosion around piers may have happened when tsunami surged up and down the area.

Deposits of sand, which may have taken long time to accumulate, cover the very flat sub-soils (maybe a flat laterite layer). As far as we have surveyed, earthquake-induced lateral soil flows were seldom and insignificant. A masonry bridge in Fig. 4, however, shows that heavy structures can sink straight into sand deposits. This uneven settlement of the bridge may have caused by either sand liquefaction or tsunami surge, which might have eroded the bottoms of piers (See river bed depths in Fig. 4).

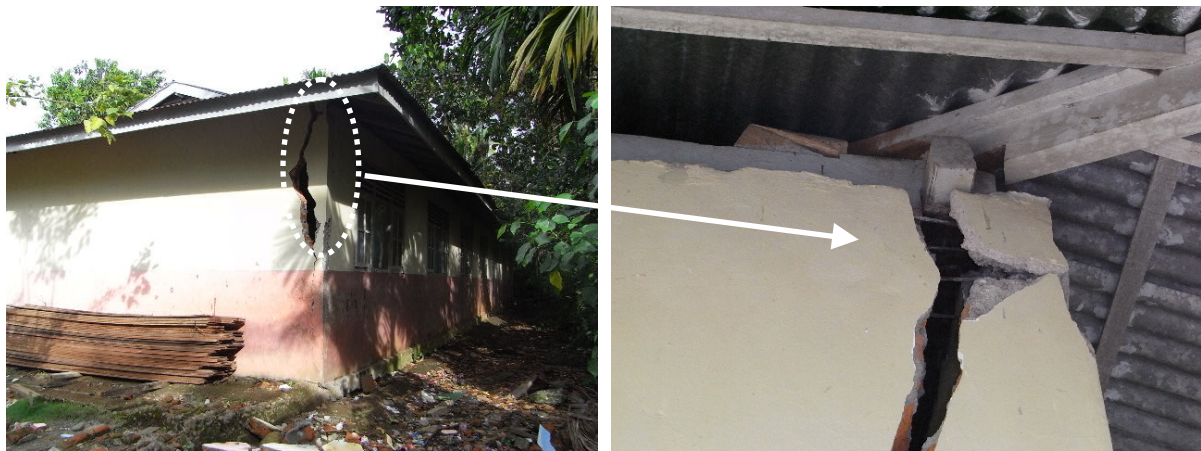
Fig. 5. Damage to URM wall due to pull-out failure at collar beam joint.

Integrity of beams provided at the top of URM walls (lintel beams and collar beams) are most essential to effectively confine those walls, and reinforcing bars at beam-beam and beam-column joints should be carefully detailed so that they are not easily separated into members at their joints due to pull-out failure (see Figs. 5 and 6). Strengthening of the weak joints above wall is of highest priority for existing confined masonry buildings.

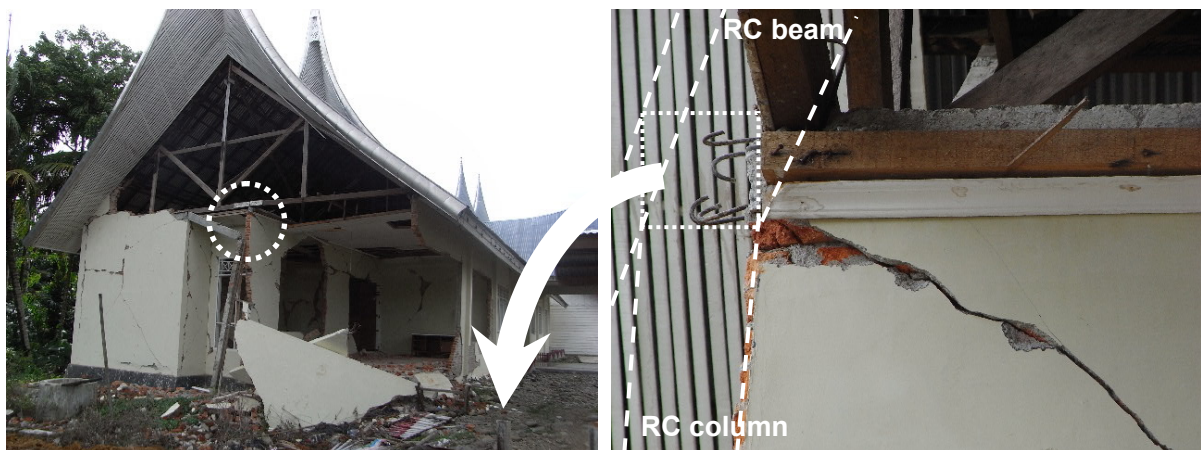
Fig. 6. Out-of-plane failure of URM wall due to pull-out failure at beam-column joint.

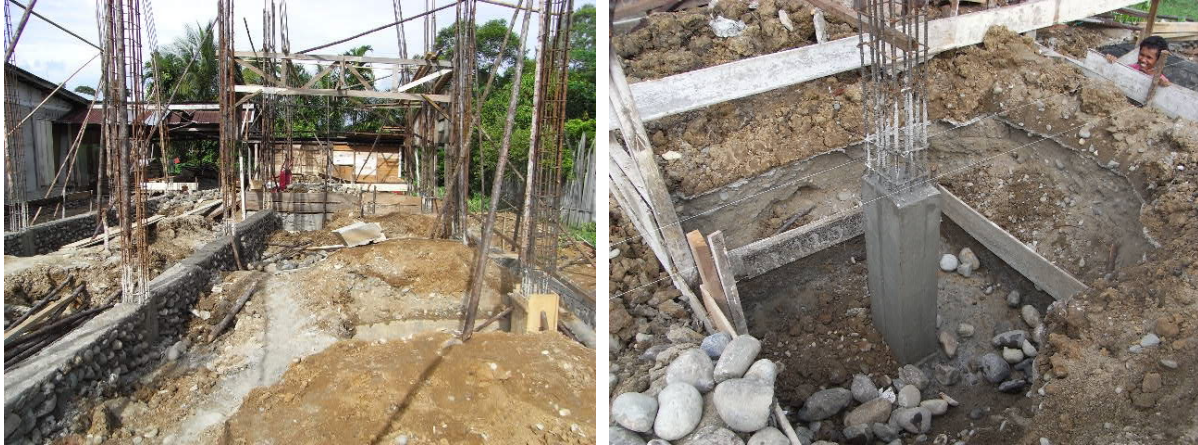
Foundations should be properly designed and constructed for successful performance during strong shakings. Foundation beams in the affected areas were often found unreinforced and structurally independent of neighboring columns. Furthermore, they were often provided mainly in one direction and were not provided in the transverse direction (see Fig. 7).

Fig. 7. Unreinforced foundation beams are provided only in the longitudinal direction (left). Column reinforcement needs to be properly embedded into footing slab to form a rigid foundation system (right).

To form a rigid foundation system, reinforcing bars should be properly provided in foundation beams, footing slabs and columns above, and they should be properly embedded and anchored into the connection to avoid joint failure, which may lead to catastrophic damage to a superstructure.

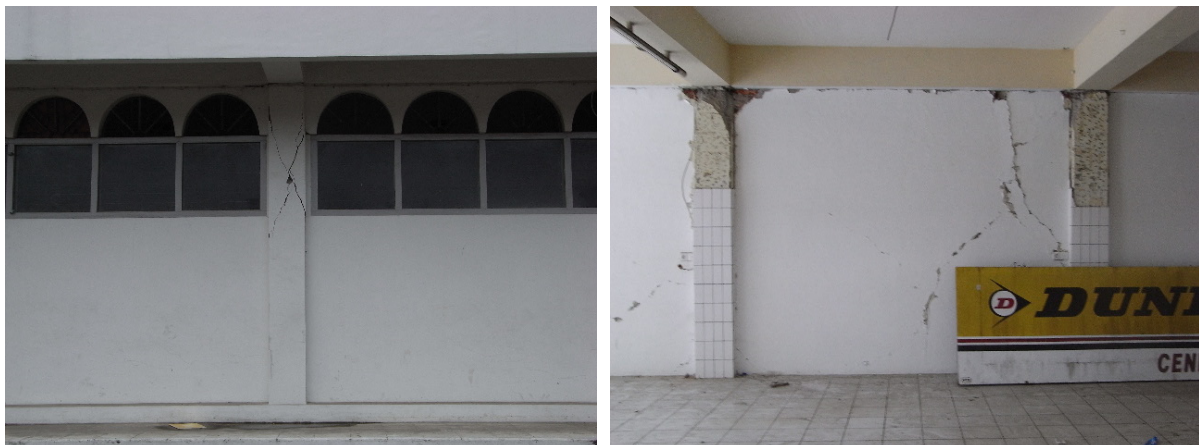
The contribution of URM walls that is usually neglected in the structural design stage may have great effects on the building's behavior such as column shortening and lateral resistance (see Fig. 8). In evaluating capacities of buildings, it is therefore essential to consider their contribution to structural performance to properly estimate their seismic capacities, although they may be deemed "nonstructural members" during structural design.

Fig. 8. URM walls are contributing to column shortening and lateral force resisting mechanism.

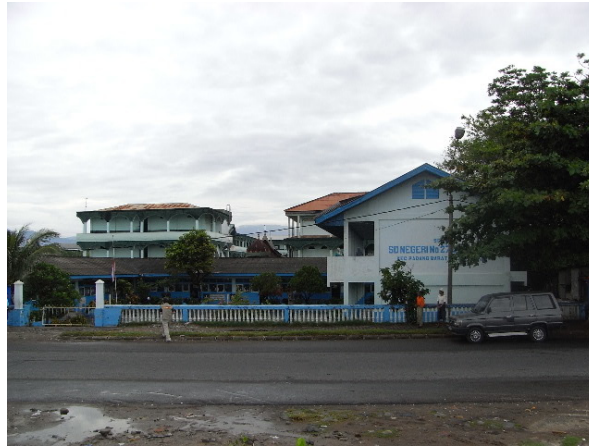
Fig. 9. Multistory school buildings with balcony directly accessible from the ground level can be primary candidates for practical tsunami shelters.

Tsunami attack is a life-threatening event along the coastal areas. Tsunami dikes should be provided especially where essential facilities are centered. Constructing tsunami shelters would be another possible solution to provide safe facilities to residents in the tsunami-prone areas. Multistory school buildings that are redesigned and retrofitted against both earthquake and tsunami loads expected at the site can be primary candidates for the shelters (see Fig. 9). Providing a stairway directly accessible from ground level to

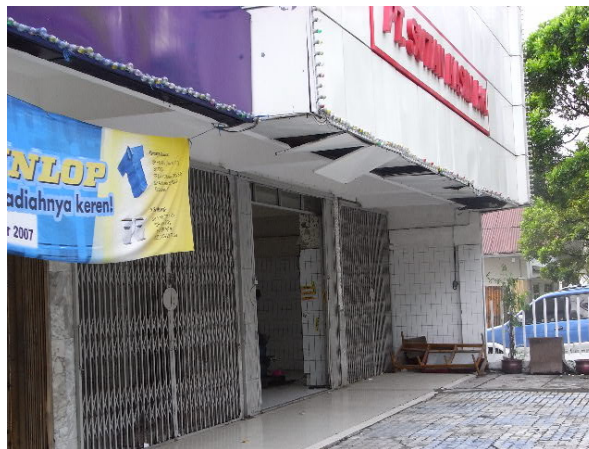
Damage to nonstructural elements is found in some commercial buildings, and they are often left damaged long after an earthquake causing hazard likely to fall down (see Fig. 10). They would cause secondary damage due to aftershocks, heavy rainfall, strong wind etc., and removal of falling hazard is strongly recommended immediately after damage.

Fig. 10. Ceiling boards are still left damaged 4 months after the last event.
