SEISMIC REHABILITATION OF SCHOOL BUILDINGS IN JAPAN

ABSTRACT: Following the 1995 Hyogoken-nambu (Kobe) earthquake, various integrated efforts have been directed toward upgrading seismic performance of vulnerable school buildings. In this paper, damage statistics of school buildings due to the Kobe earthquake, criteria to identify their vulnerability, the subsidy program for seismic rehabilitation, and their implementation examples, are briefly described, together with recent challenging efforts for further promotion of seismic rehabilitation on a nationwide basis.

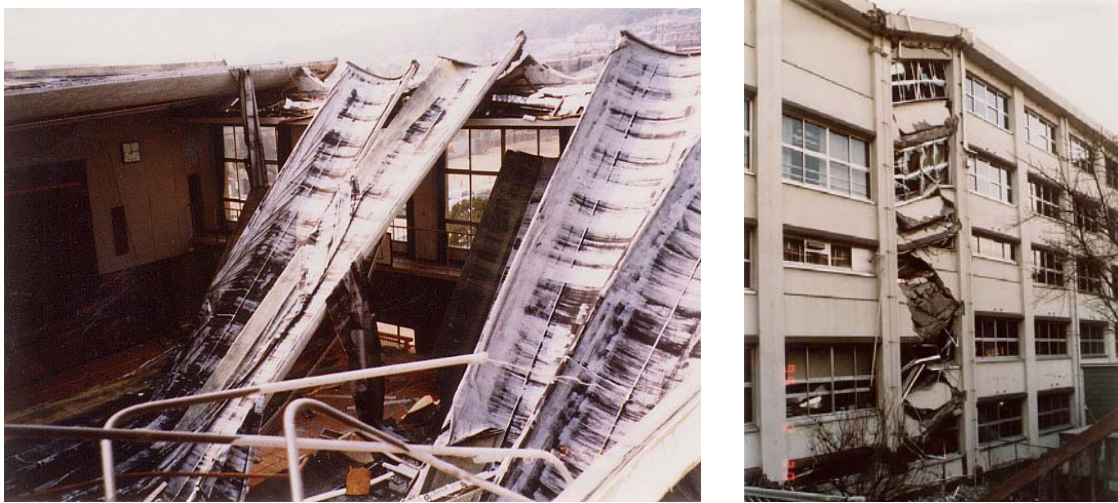
Photo 1: Seriously damaged schools (1995 Hyogoken-nambu earthquake, AIJ 1997)

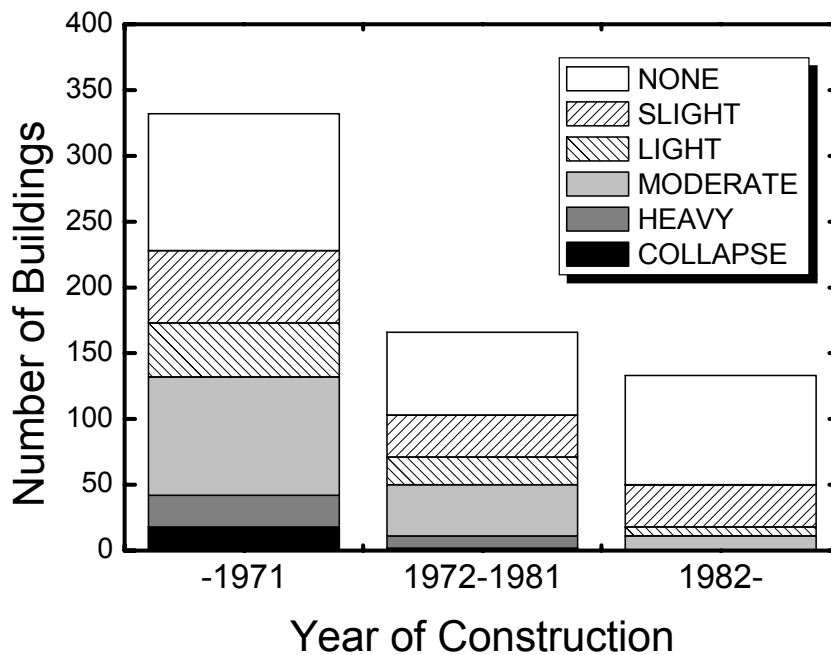
Figure 1 shows the damage statistics of RC school buildings due to the Kobe earthquake (after AIJ 1997). In the last 3 decades, the Japanese seismic design code was revised in 1971 and 1981.

Figure 1: Damage statistics of RC schools due to the 1995 Kobe earthquake (after AIJ 1997)

As can be found in the figure, the damage rate is highly dependent on the code generation, and those designed in accordance with the pre-1981 code had more serious damage.

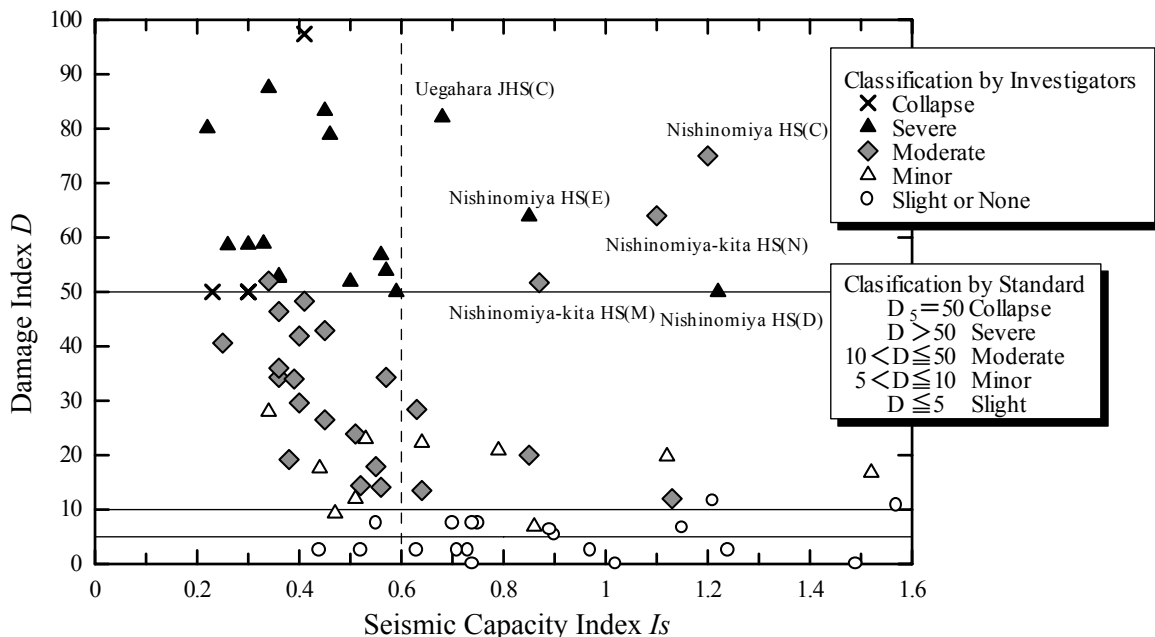
In **Figure 2** is shown the relationship between damage rate index D and seismic capacity index I_s of surveyed RC buildings, where D and I_s are computed according to the Guidelines for Post-earthquake Damage Evaluation (JBDPA 1991) and the Standard for Seismic Evaluation of Existing RC Buildings (JBDPA 1990a), respectively (Okada et al. 2000). The basic concept and procedure to compute I_s is briefly described in **APPENDIX**. The figure reveals that the damage rate is inversely correlated with the computed I_s values, and that buildings with I_s value equal to or exceeding 0.6, which is a required seismic capacity index defined in the Standard for non-essential (standard occupancy) buildings, sustain generally minor damage. It should be pointed out, however, that 6 buildings in **Figure 2** designated (C), (D), (E), (M), and (N) are considered to have serious damage, although their I_s values are higher than 0.6. Further investigations conclude that the observed serious damage may be attributed to the directivity of predominant ground shaking that agrees with the longitudinal direction (generally weaker than the transverse direction due to fewer shear walls in school buildings) of these 6 buildings, and their larger residual displacements due to relatively ductile failure mode but low lateral strength.

Note: D_i index is calculated based on the number of columns B_i categorized in Damage Class i defined in the Guideline, and the total number of columns A (JBDPA 1991). The overall rating of a building $D (= \sum D_i, i = 1 \text{ to } 5)$ is then determined depending on the criteria as shown in the legend above. Although a new index R denoting a residual seismic capacity is employed in the Guideline revised in 2001 (JBDPA 2001) considering experiences of recent damaging earthquakes, calibrations made in the revised Guideline show that these two indices roughly correspond in the form of $R = 100 - D$.

Figure 2: Seismic capacity index I_s vs. damage level (Okada et al. 2000)

has I_s index less than a criteria value of 0.7, which is determined considering the relationship between observed damage to schools and their I_s values shown in **Figure 2** and the essential role as refugee centers as well as educational facilities, the building is to be seismically rehabilitated with financial support by MEXT so that I_s value should not be less than the criteria 0.7.

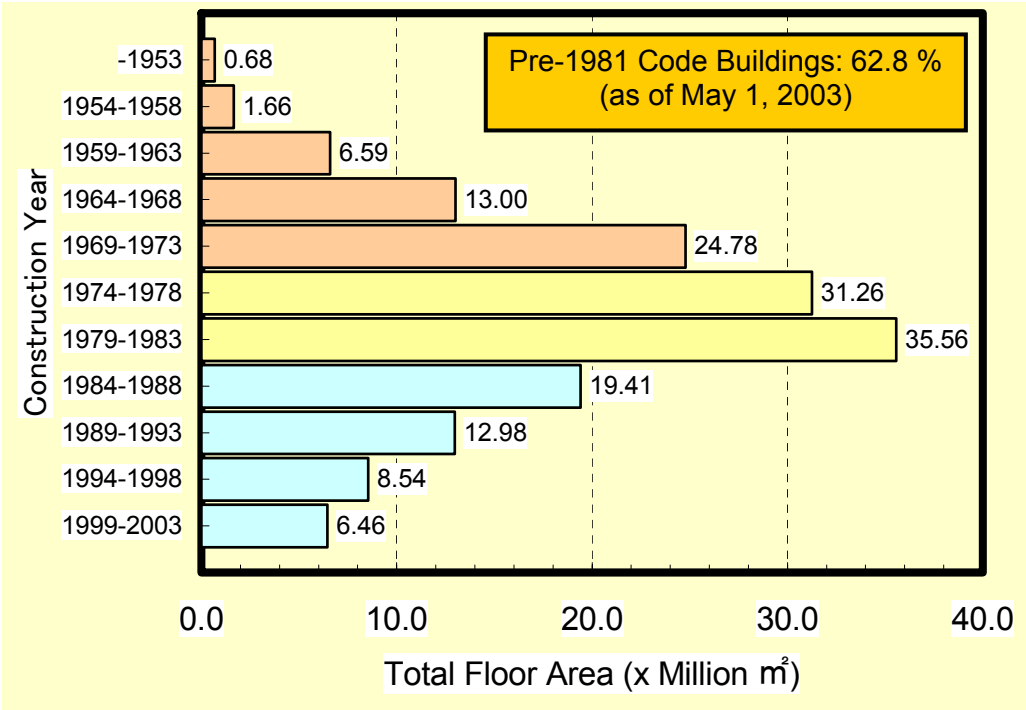
The Ministry of Education (MEXT) also has directed significant efforts toward upgrading seismic performance of vulnerable school buildings, since more than 60 % of the current school building stock are, as shown in **Figure 3**, designed in accordance with pre-1981 code. To promote the seismic rehabilitation program, the MEXT financially supports the local governments to upgrade school buildings as shown in **Table 1** (Kabeyasawa 2000).

Figure 3: Total floor area of existing school facilities (after MEXT HP)

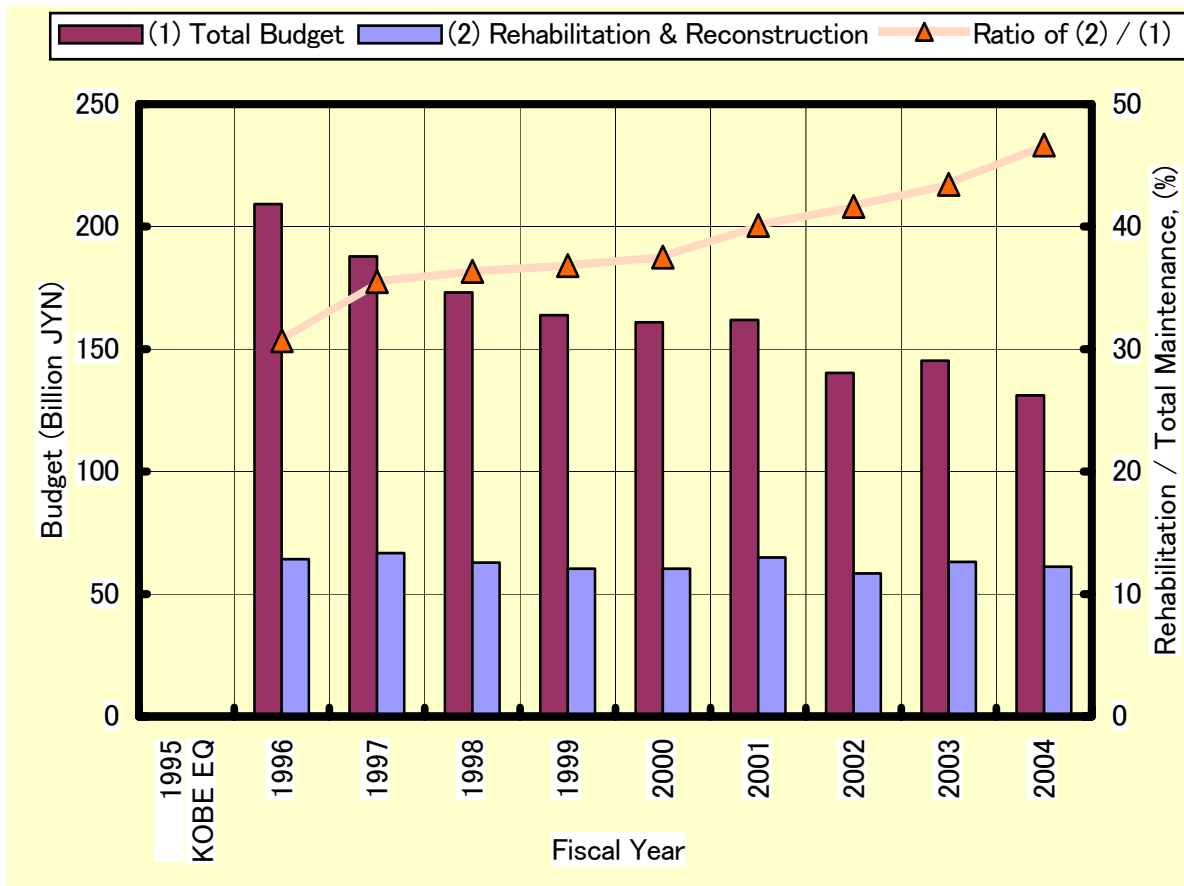
Figure 4 shows the subsidy budget of the MEXT for public elementary and middle schools. The total budget for school facilities covers new construction, structural extension, rehabilitation, and reconstruction. Although the total budget appropriated for school facilities has been decreasing over the last decade, primarily due to social and economic trends such as declining birthrate and consequent reduction in number of students, and the nationwide recession, the budget ratio for seismic rehabilitation and reconstruction of vulnerable buildings has been increasing.

Figure 4: Subsidy budget for public elementary and middle schools

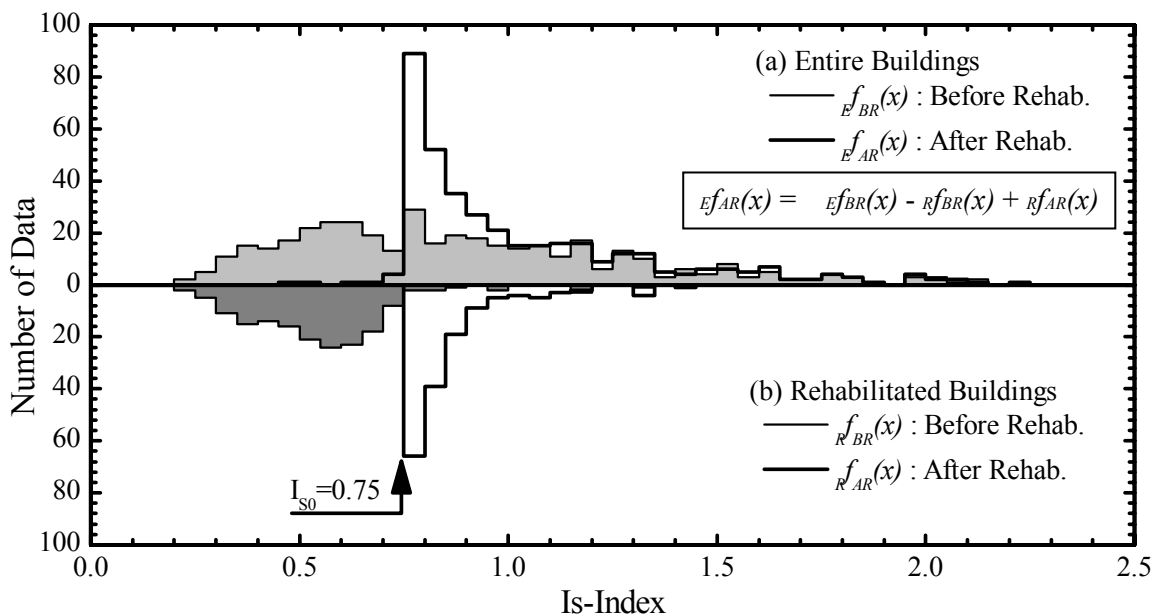
The shaded area in **Figure 7(a)** shows the distribution of seismic capacity index I_s in the first story of entire 219 school buildings, where I_s indices in both principal directions of each building evaluated in accordance with the Standard are plotted. As can be found in the figure, the distribution has two peaks, and a distribution containing a peak at smaller I_s index corresponds to the longitudinal direction while the other to the transverse direction. This is generally because a school building has fewer shear walls in the longitudinal direction than in the transverse direction where shear walls are in general placed between each classroom.

Figure 7(b) shows the distribution of I_s indices in the first story before and after rehabilitation of 143 buildings which are identified rehabilitation candidates. In the City, the decision criteria I_{s0} to

Figure 7: Distribution of I_s index in the first story

screen sound buildings is set 0.75 considering the basically required seismic capacity index of 0.6 and the importance factor of 1.25 for school buildings. As can be seen in the figure, seismic capacities of rehabilitated buildings have a significant peak just beyond $I_s = 0.75$, and then sharply decrease.

Knowing the frequencies of existing and rehabilitated buildings described above, the I_s index distribution (i.e., frequency) of entire buildings including rehabilitated buildings can be obtained as shown by a thick line in **Figure 7(a)**. The figure shows that the rehabilitation significantly improves seismic capacities of RC school buildings in the City.

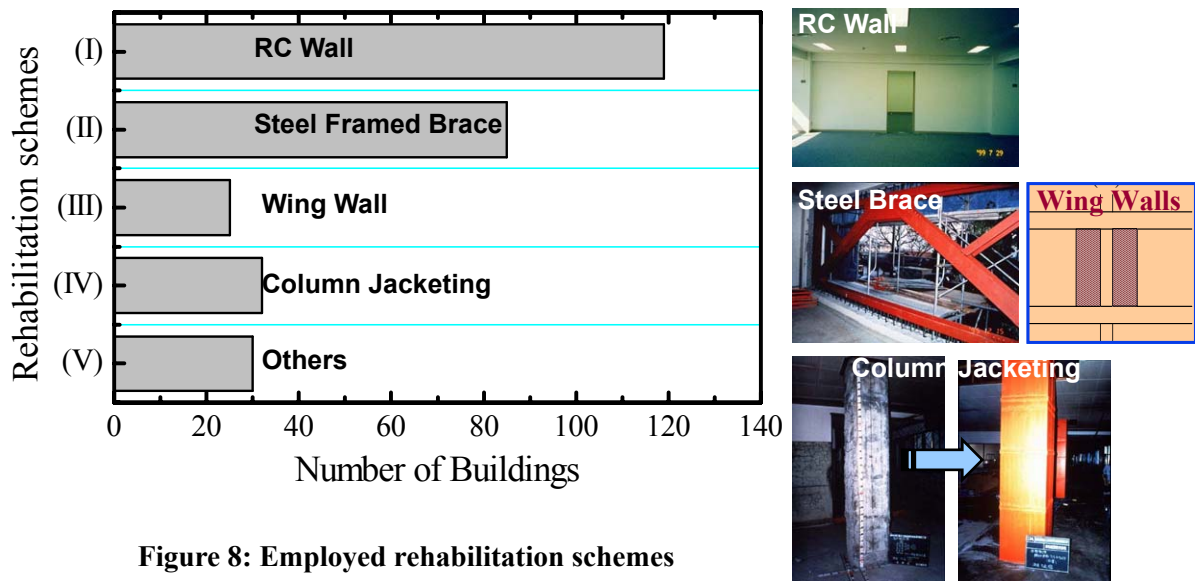
Figure 8: Employed rehabilitation schemes

Figure 8 shows rehabilitation schemes employed in 143 rehabilitation candidates. It should be noted that some buildings employ not a single but several schemes together, and the total number in the figure is much larger than 143. In rehabilitating an existing RC building, a scheme to infill new RC walls into existing bare frames had been most conventionally applied in Japan because of numerous practical experiences as well as experimental and analytical researches extensively made on this technique. Although it is one of the most reliable strategies to upgrade a seismically vulnerable RC building, *infilling* often causes less flexibility in architectural and environmental redesign and/or the increase in building weight sometimes leads to costly redesign of foundation. On the other hand, steel framed braces have been more widely applied in recent years, particularly following the 1995 Kobe earthquake, to overcome such shortcomings resulting from the conventional RC walls mentioned above. As can be found in **Figure 8**, RC walls are most widely used but steel framed braces are applied to approximately 60 % of rehabilitation candidates in Ota City, which is same as the recent trends of seismic rehabilitation schemes employed in other cities in Japan.

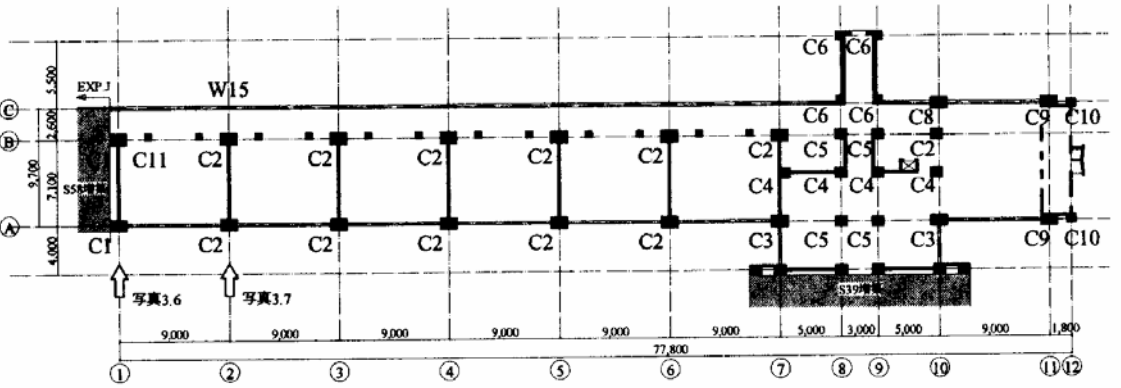
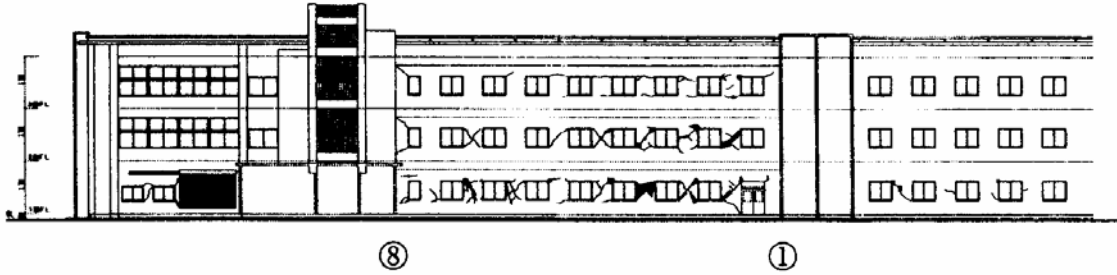
Building No. 1, which had not been rehabilitated at the time of the quake, sustained damage to columns in frame (A) and exterior walls in frame (C). **Figure 9** shows the plan view and observed damage pattern in frame (C).

(a) Plan view

(b) Damage in frame (C)

Figure 9: Plan view and damage of Building No. 1 (Tanaka 2004)

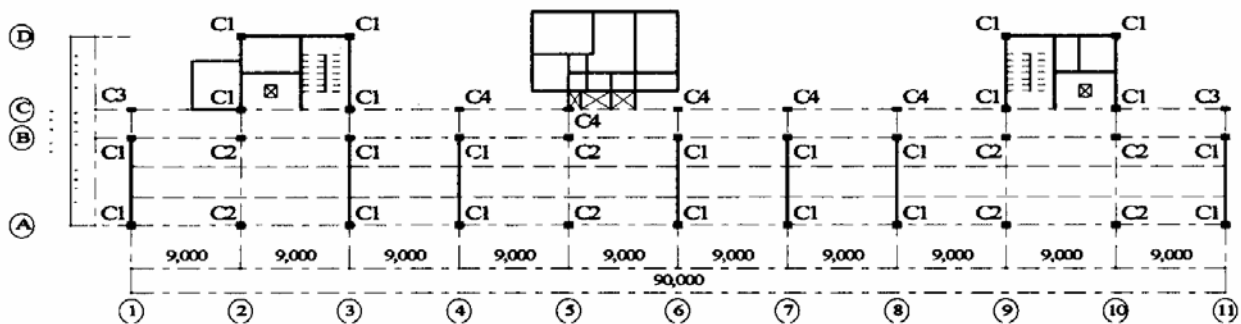
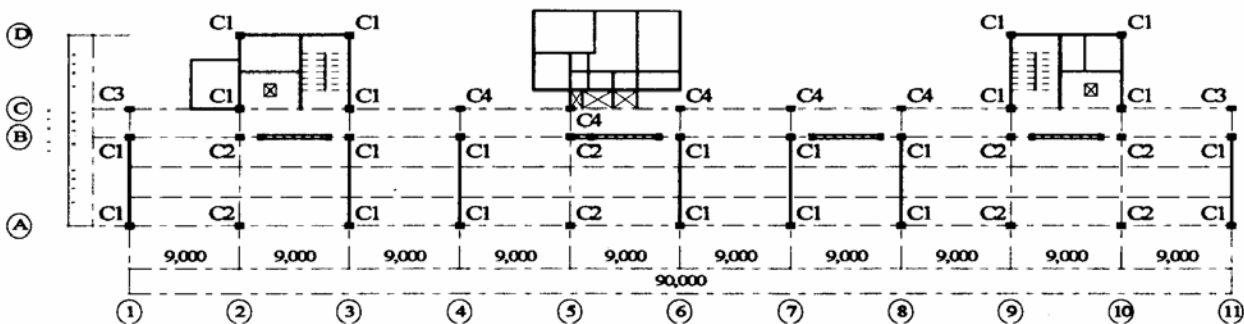
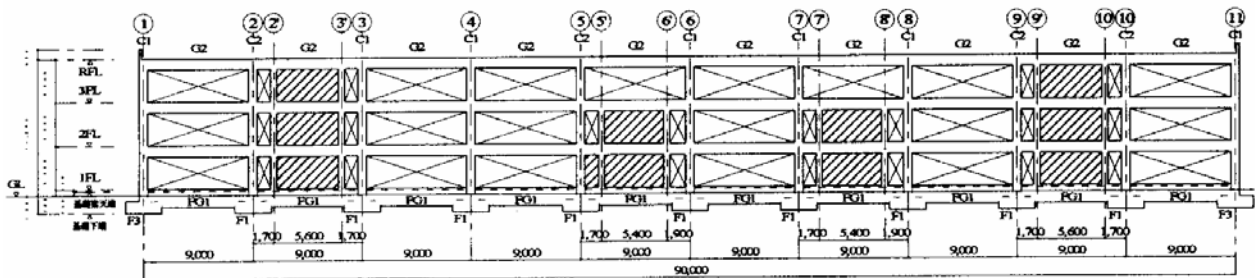
Although Building No. 2 has a structural design similar to the other one, it sustained no structural damage since it had been, prior to the 2003 event, seismically rehabilitated after the Kobe earthquake. **Figure 10** shows the original and re-designed building. As can be found in the figure, Building No. 2 is rehabilitated in frame (B) with infilled RC shear walls having new boundary columns on both sides, which is one solution recommended in the Technical Guide (MEXT 1998a).

(a) Original plan view

(b) Redesigned plan view

(c) Redesigned elevation view

Note: The hatched areas above indicate new shear walls installed before 2003 event.

Figure 10: Plan and elevation view of Building No. 2 (Tanaka 2004)

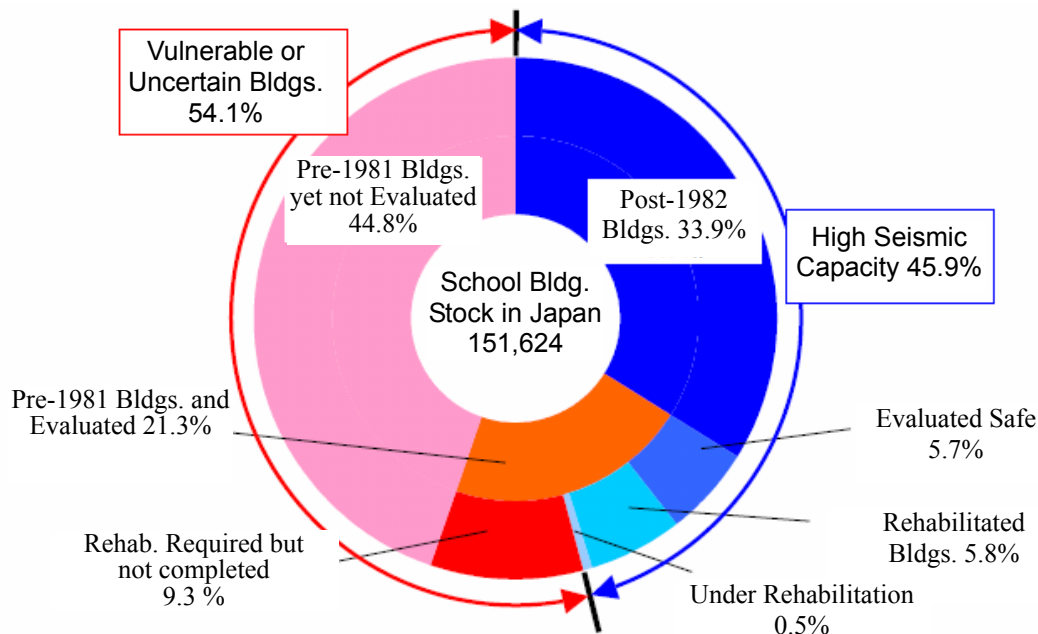
Figure 11: Review results on earthquake preparedness of school buildings (as of March 2001)
