QUICK REPORT ON  
DAMAGE INVESTIGATION OF BUILDINGS AND HOUSES  
DUE TO MAY 27, 2006, CENTRAL JAVA EARTHQUAKE,  
INDONESIA

Masaoki TESHIGAWARA (Nagoya University)  
and  
Yoshiaki NAKANO (IIS, the University of Tokyo)

Building Survey Team  
Japan Society of Civil Engineers (JSCE)  
and  
Architectural Institute of Japan (AIJ)

June 16, 2006

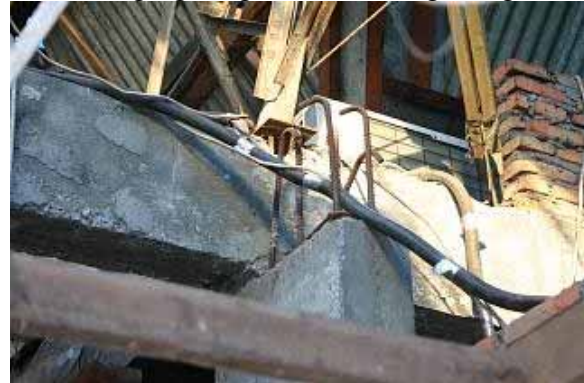
### Amongrogo Sport Center (RC 3F)

Extensive damage was found in cantilever RC columns on the top floor as well as in the roof system. The column damage may be attributed to the inertia force due to shaking, the inward force acting on the columns due to collapse of the roof, and the small amount of reinforcement provided in the columns.

Amongrogo Sport Center / Collapsed roof system associated with column failure underneath

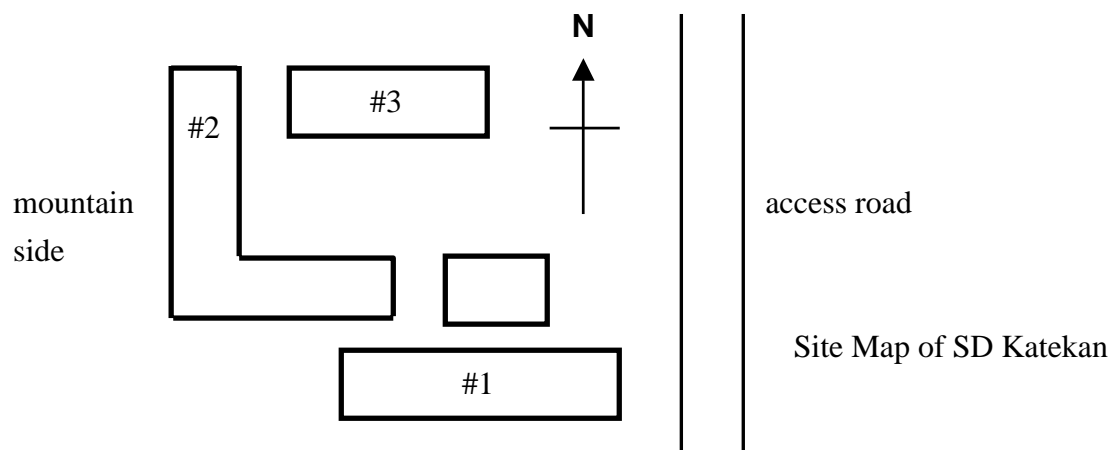
Katekan Elementary School (SD Katekan at Katekan, Kecamatan Gantiwarno / URM & URM+RC column / 1F)

The school had 3 buildings, one of them (building #2) was stone masonry structure constructed in the 1970s while the other two buildings (#1 and #3) were URM structure with RC columns. Each classroom of the building #1 had 3 bays, each of which was 3m long. Damage to the roof system and ceiling boards was found in buildings #1 and #3 while cracks in URM stone walls were found in building #2.
