GUIDELINE FOR POST-EARTHQUAKE DAMAGE EVALUATION AND REHABILITATION OF RC BUILDINGS IN JAPAN

Yoshiaki NAKANO¹, Masaki MAEDA², Hiroshi KURAMOTO³, and Masaya MURAKAMI⁴

SUMMARY

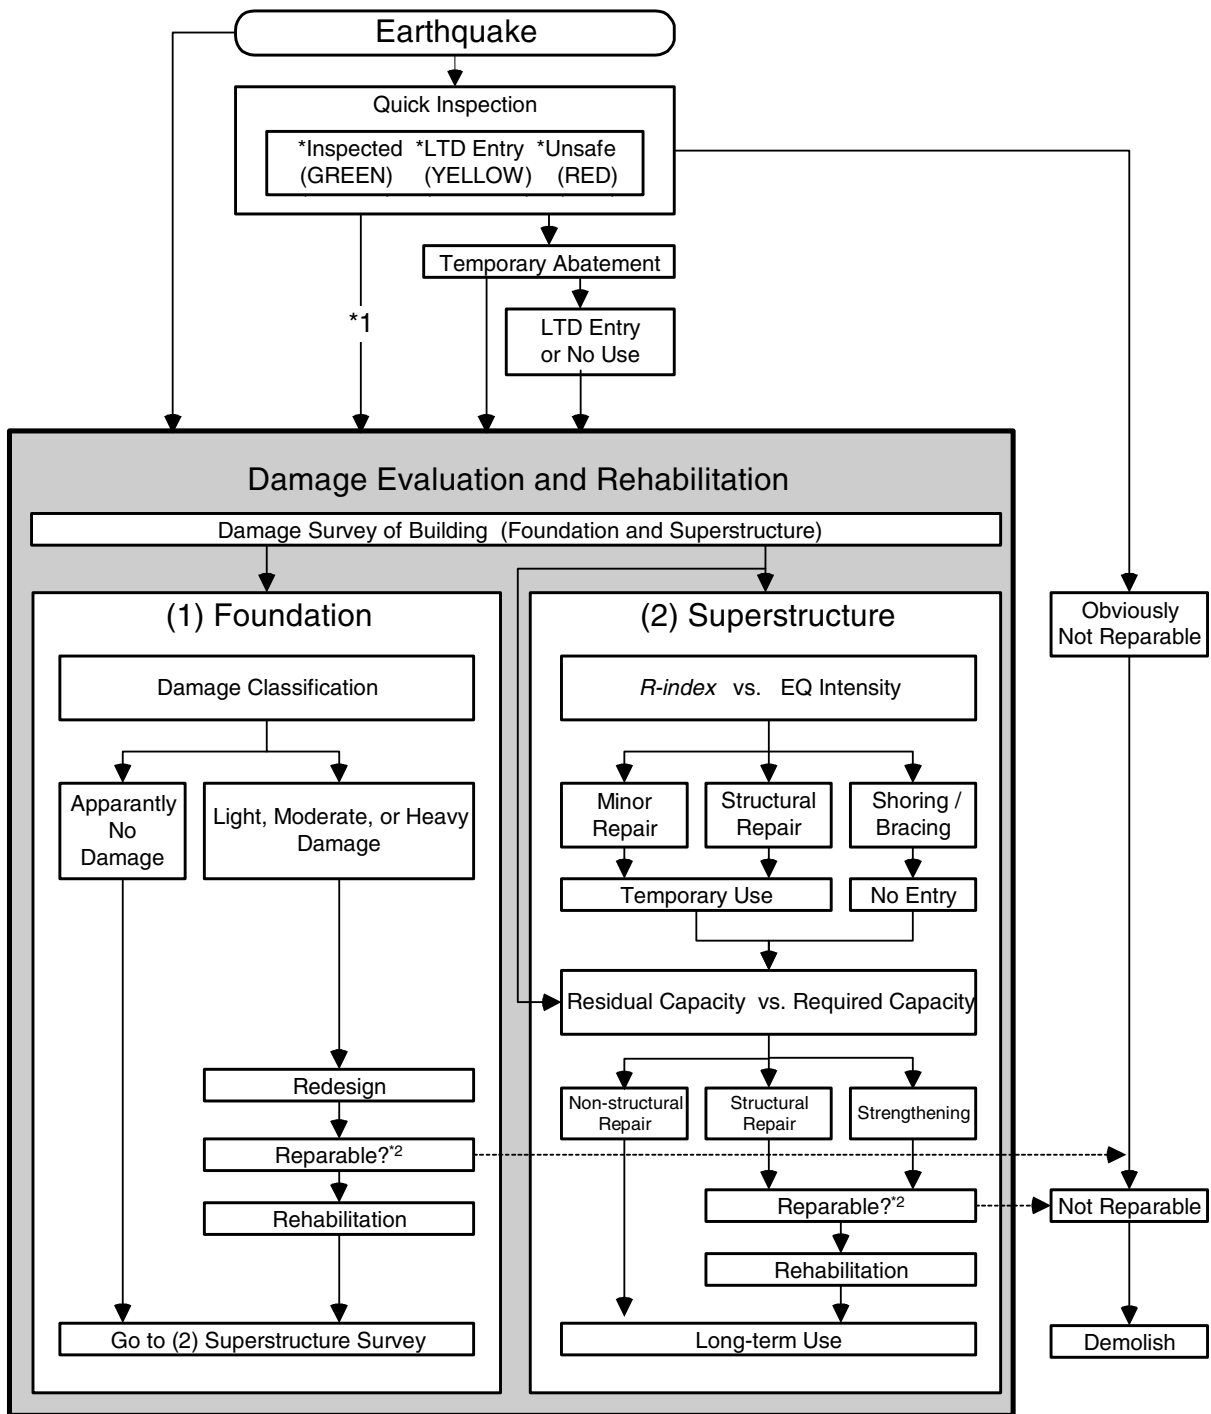
Figure 1: General Flow of Damage Evaluation and Rehabilitation Assumed in the Guideline

Damage evaluation of a building is performed on foundation system and superstructure system, respectively, and the damage rating of each building is made in a combination form for each system such as “no damage in foundation and moderate damage in superstructure”. Rehabilitation actions necessary for the building are then determined considering identified damage. **Figure 1** shows the general flow of damage evaluation and subsequent rehabilitation actions.

*1 Damage evaluation fundamentally includes buildings after quick inspection since the inspection results do not necessarily provide sufficient information related to the residual seismic capacity which is most essential to judge appropriateness of continued long-term use of buildings.

*2 Economic as well as technical issues should be considered.

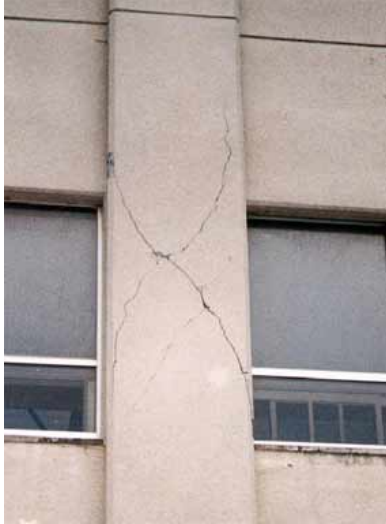
Damage class III:
(left) Cracks with a width of about 2mm on structural concrete
(right) Spalling concrete cover and slightly exposed rebar

A damage classification of columns and shear walls is performed based on the damage definition shown in **Table 2** and **Photo 1**. As was revealed in the past damaging earthquakes in Japan, typical life-threatening damage is generally found in vertical members, and the Guideline is essentially designed to identify and classify damage in columns and walls rather than in beams. When damage is found in beams, the damage classification needs to be performed considering their deficiency in vertical load carrying capacity as well as lateral resisting of columns adjacent to damaged beams. As defined in **Table 2**, columns and walls are classified in one of five categories I through V. **Figure 2** schematically illustrates the load carrying capacity, load-deflection curve, and member damage class.

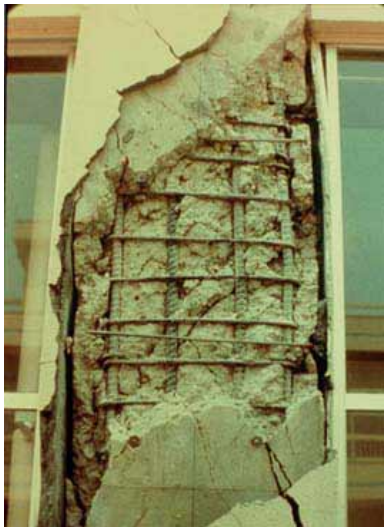
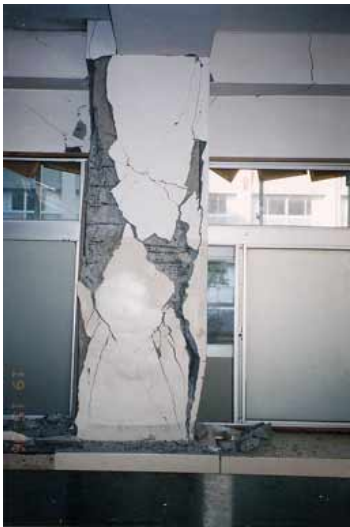
Damage class IV:
Exposed rebar without buckling or fracture

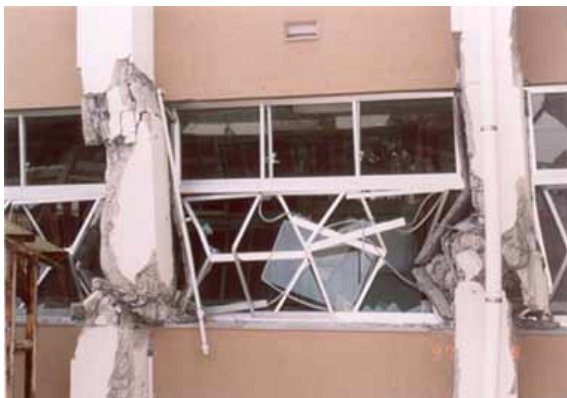
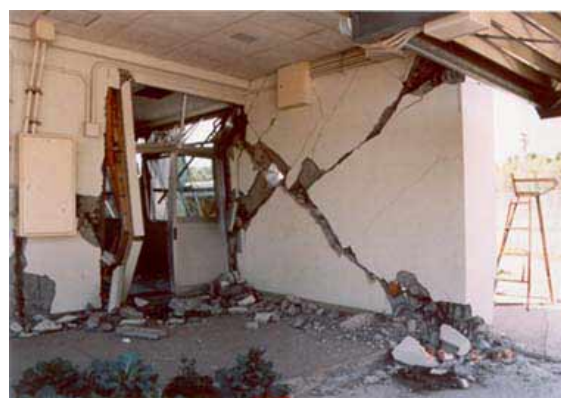
Photo 1: Damage Class Examples

Damage class V

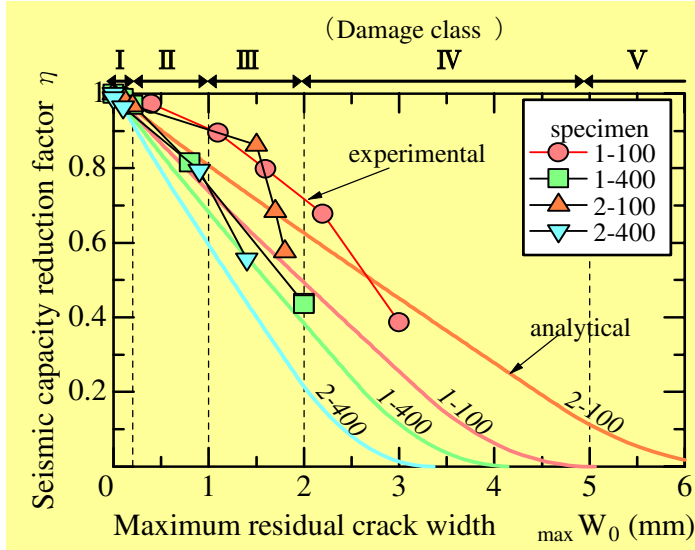
Figure 4: Seismic Capacity Reduction Factor η Obtained from Experimental Investigations

Note: Experimental results (Maeda et al. [3]) for 4 beam specimens subjected to cyclic loadings are shown here, where the relationship between the reduction factor η calculated in accordance with the concept shown in **Figure 3** and the maximum residual crack width $maxW_o$ is plotted. Curves shown together in the figure are obtained assuming Takeda hysteretic model.

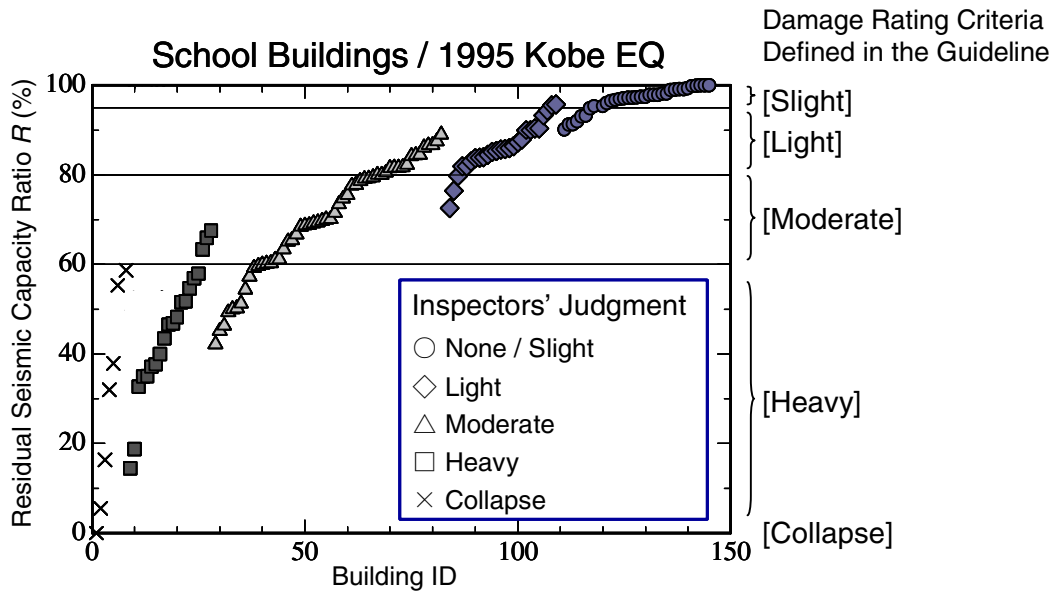
Figure 5: Residual Seismic Capacity Ratio R vs. Observed Damage

The residual seismic capacity ratio index R defined in (2) can be considered to represent damage sustained by a building. For example, it may represent no damage when $R = 100\%$ (100% capacity is preserved), more serious damage with decrease in R , and total collapse when $R = 0\%$ (no residual capacity). To identify the criteria for damage rating, R values, calculated from the simplified procedure shown in **Eq.(3)**, of 145 school buildings that experienced the 1995 Kobe earthquake are compared with observed damage and judgment by experts as shown in **Figure 5**. Based on the results shown in the figure, the Guideline then defines the damage rating criteria shown below.

It should be noted, however, that the boarder line between two adjacent damage rating such as [heavy damage] and [moderate damage] is not necessarily explicit, and overlapping or gray zones may be found in the figure. Those close to the damage rating criteria should be categorized after careful damage examination rather than a simple numerical judgment.

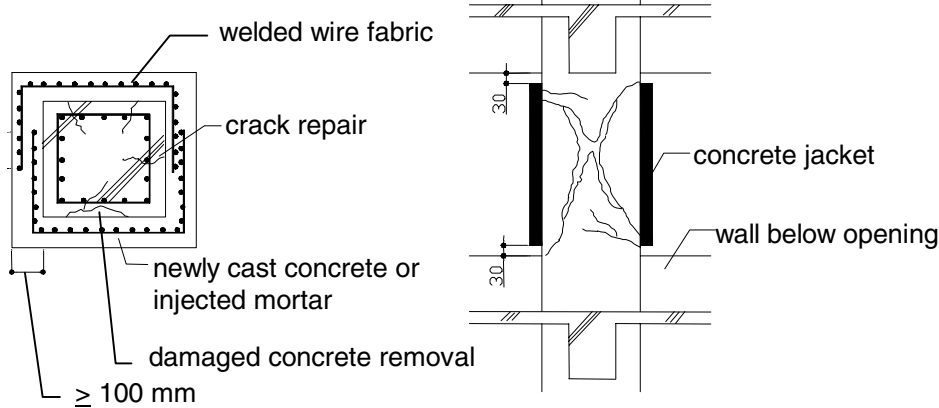
Applicable to: [temporary restoration] (repair) [strengthening]

Applicable Damage Class: II III IV V

1. Rehabilitation with welded wire fabric and concrete jacketing

To facilitate the rehabilitation design and construction, visual instructions consisting of 19 examples for foundation and 28 examples for superstructure are provided together with photo examples. **Figure 6** shows a typical example for building superstructure.
